Clear Creek / Standley Lake Watershed Agreement

2016 Annual Report

Clear Creek Watershed Annual Report – 2016

Prepared by:
Hydros Consulting Inc.
1628 Walnut Street
Boulder, CO 80302

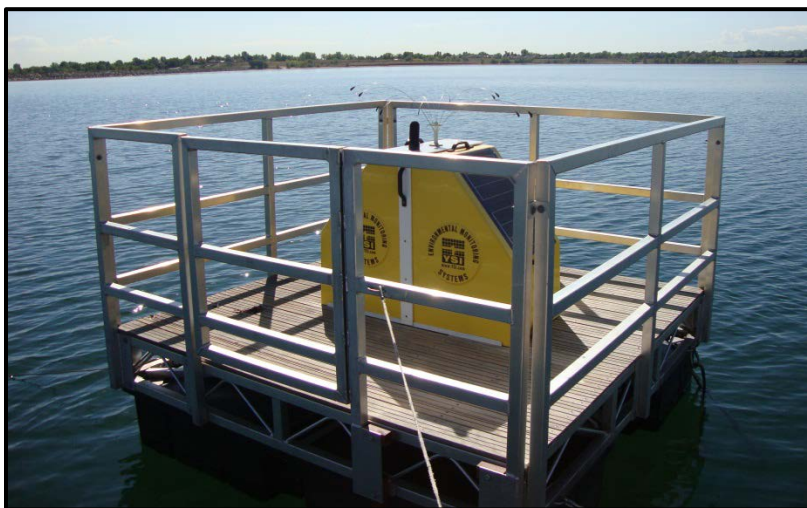
Figure 3. Water-Quality Profiler at SL10

- **Daily Profiles** –Standley Lake water quality is measured four times per day using an automated profiler (Figure 3). Measurements are taken every meter, from the surface to within 2 meters of the bottom. The profiler is equipped with a multi-probe sonde which provides readings of water temperature, dissolved oxygen, pH, conductivity, turbidity, oxidation/reduction potential (ORP), and chlorophyll *a* concentrations.

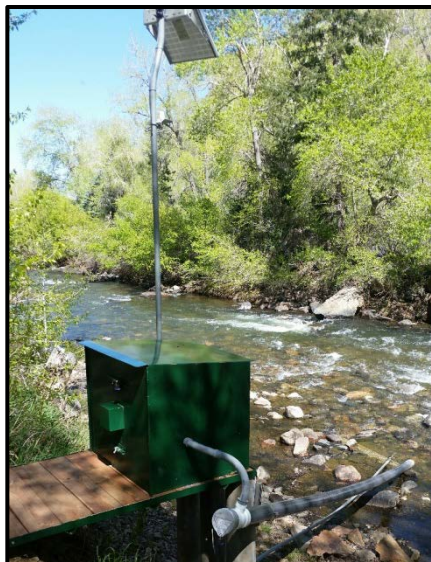
The new SLIGA CC59 Sampling Station

In 2016, Northglenn constructed a platform and box at the site and an Autosampler (AS) was installed. The monthly collection of ambient 24-hour composites using the SLIGA autosampler began in April 2016. In the spring of 2017, a sonde was installed and connected to a datalogger. The sonde, a YSI EXO2, measures depth, temperature, pH, ORP, turbidity and fluorescent dissolved organic matter (fDOM) data. These *in-situ* data will be collected on a seasonal basis as this site becomes very shallow in the late summer. The sonde will be removed when water depth at the site becomes too shallow.

In 2016 a new second sampling station was installed at the CC59 location. The original CC59 monitoring site is located on Clear Creek in Golden, approximately 300 yards upstream of the Church Ditch headgate in Golden. The new CC59 sampling station is located approximately 100 ft upstream of the existing monitoring station. The City of Golden operates the original CC59 station, primarily for the collection of stormwater samples. The collection of ambient samples at this station was interfering with stormwater sampling. These ambient samples are considered a critical part of the Standley Lake watershed model. The new station was installed to allow for the continued collection of composite ambient samples at the CC59 location.

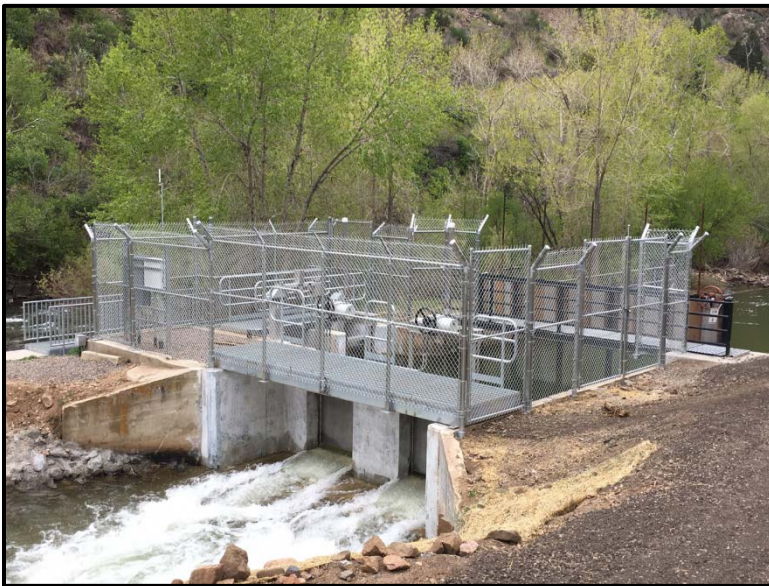
Prior to the 2017 irrigation season, the Church Ditch Water Authority (CDWA) completed the construction of a new headworks structure with improved operational capabilities. This structure provides Church Ditch staff with better control of flows diverted from Clear Creek. It also provides the ability for remote access to gate controls. This capability simplifies flow adjustments and allows immediate shutdowns in the event of contamination in Clear Creek. The structure also allows for the removal of sediment from the diversion channel upstream of the headworks. This will reduce sedimentation from Clear Creek and help minimize ditch maintenance.

New Church ditch headworks structure.

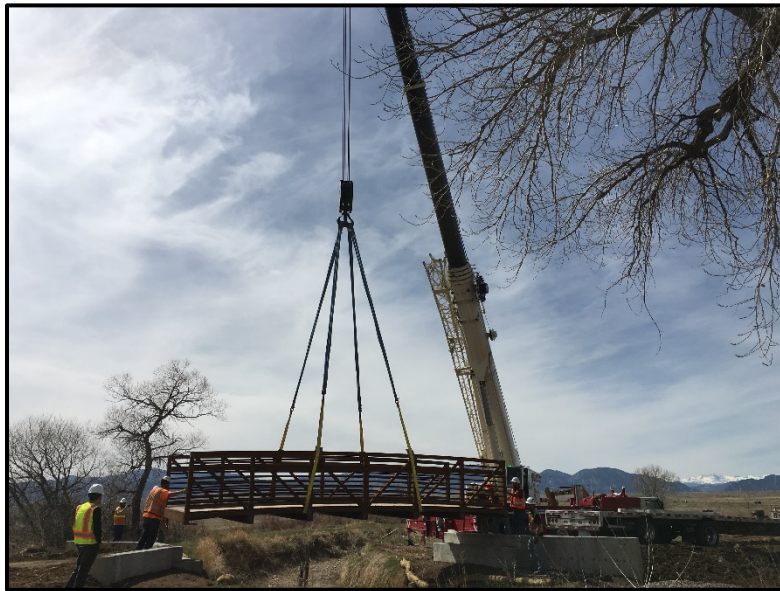
[Installation of new pedestrian bridge over Church ditch](#)

contaminants from entering the ditch. In 2016, such projects included the placement of two pedestrian bridges, one culvert ditch crossing, and multiple utility bores. Lastly, CDWA also replaced a number of user headgates—providing new headwalls, gates, and check pads where needed. These projects were completed by mixing native soil with bentonite and adding rip rap to provide bank stability.

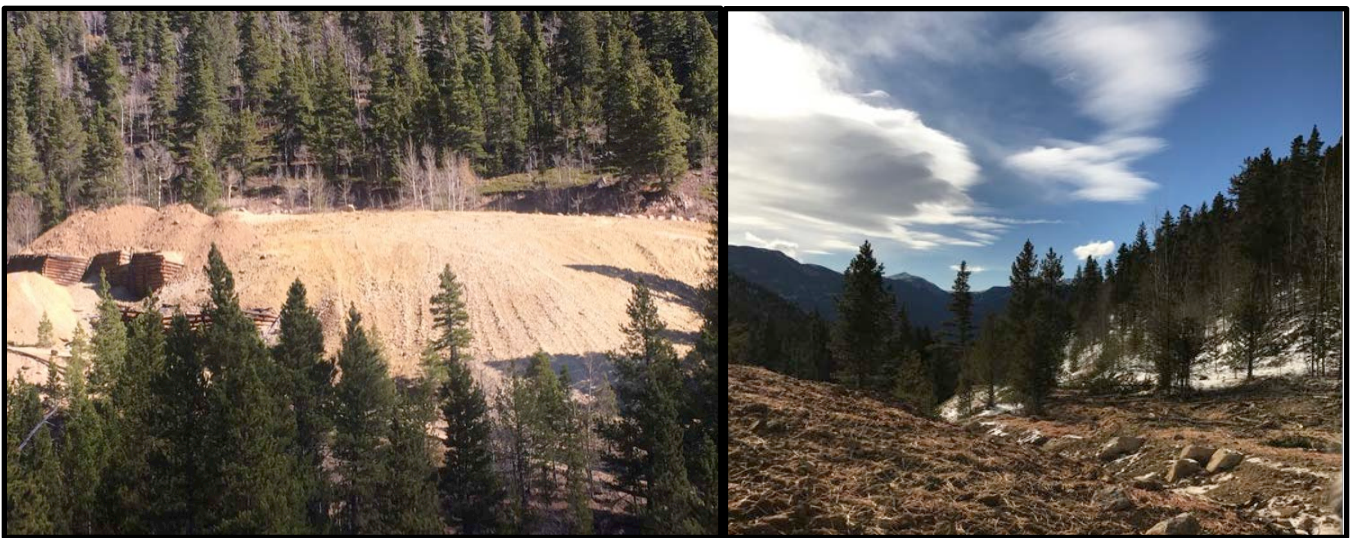
The project included four primary components. In the first, the large (0.5 acre) Gold Dirt mine waste pile was reshaped and revegetated. Second, Equator mine waste pile was removed to a repository. Third, a fluvial fan containing highly mineralized material was removed to a repository. The completion of these three activities allowed the channel of North Empire Creek to be restored.

[Gold Dirt Mine Waste Pile \(left\). Restored Channel of North Empire Creek \(right\)](#)

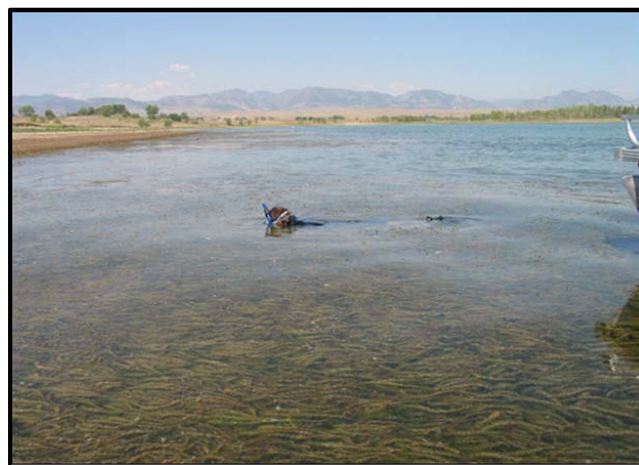
Eurasian watermilfoil near Control Site (Location M1, see Figure 14) in 2002

Eurasian Watermilfoil - Eurasian watermilfoil (EWM; *Myriophyllum spicatum* L) is a non-native, noxious aquatic weed that grows rapidly at depths of up to 35 ft. EWM can grow into dense mats that severely interfere with recreation and can provide a substrate for blue-green algae growth. Blue-green algae blooms can ultimately cause taste and odor events in drinking water supplies. EWM was first observed in Standley Lake in 1998 and positively identified in 2000. EWM weevils, an herbivorous insect specialized to EWM, have been stocked on the west side of the lake on five occasions since 2002. When an adequate weevil population is sustained, the weevils may be able to control the spread of the milfoil. A substantial decrease in milfoil densities has been observed since the weevil stocking program. Additional contributors to EMW density declines include other insects, reservoir drawdown, and competition from native plants.

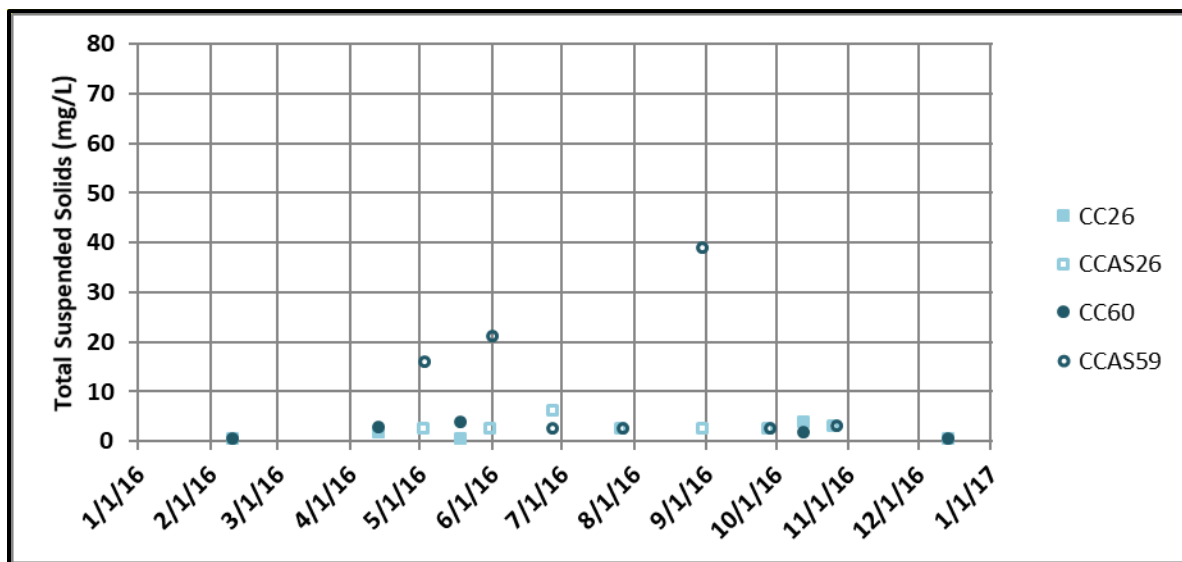
Figure 22. Total Suspended Solids Concentrations (Non-Event) in the Upper Basin, 2016

Total suspended solids concentrations in 2016 from grab samples and ambient composites from at CC59/60 and CC26 are displayed in Figure 22. The highest TSS concentration (39 mg/L) was measured at the lower station (CCAS59) on August 30, 2016. The maximum observed TSS (6 mg/L) for the upper portion of the basin (CCAS26) was observed on June 27, 2016. Changes in land use, increased anthropogenic disturbance, and decreases in forest cover tend all contribute to increased TSS concentrations at the lower station.
