Russell Gulch 2022 Abandoned Mine Sampling and Project Planning

2022-1-TURG

Final Report – December 2023

Prepared for:
Upper Clear Creek Watershed Association
Membership Support Fund / Community Support Project Fund

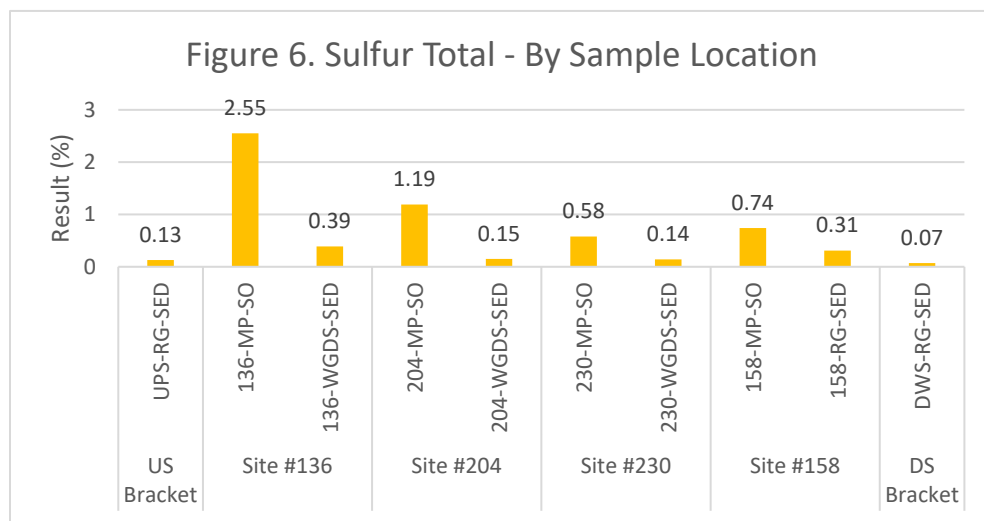
The ABP results for the waste piles at Site #136, Site #204, and Site #158 are less than -20 t CaCO₃/Kt, indicating the presence of acid-generating material (Figure 3 – red font). These values, coupled with corresponding acidic pH and sulfur content values of 2.7, 4.3, and 4.7, and 2.55%, 1.19%, and 0.74%, respectively, provide additional potential for weathering of metals and acid mine drainage (AMD) generation during precipitation events and seasonal runoff. These three (3) sites exhibited the lowest ABP values and highest Total Sulfur values of all ten (10) sites sampled. All sites exhibited acidic soil and sediment conditions, with pH ranging from 2.7 to 5.7. The ABA data will aid in assessing the in-situ treatment feasibility of utilizing neutralization material to buffer pH. (Figures 5, 6, and 7)

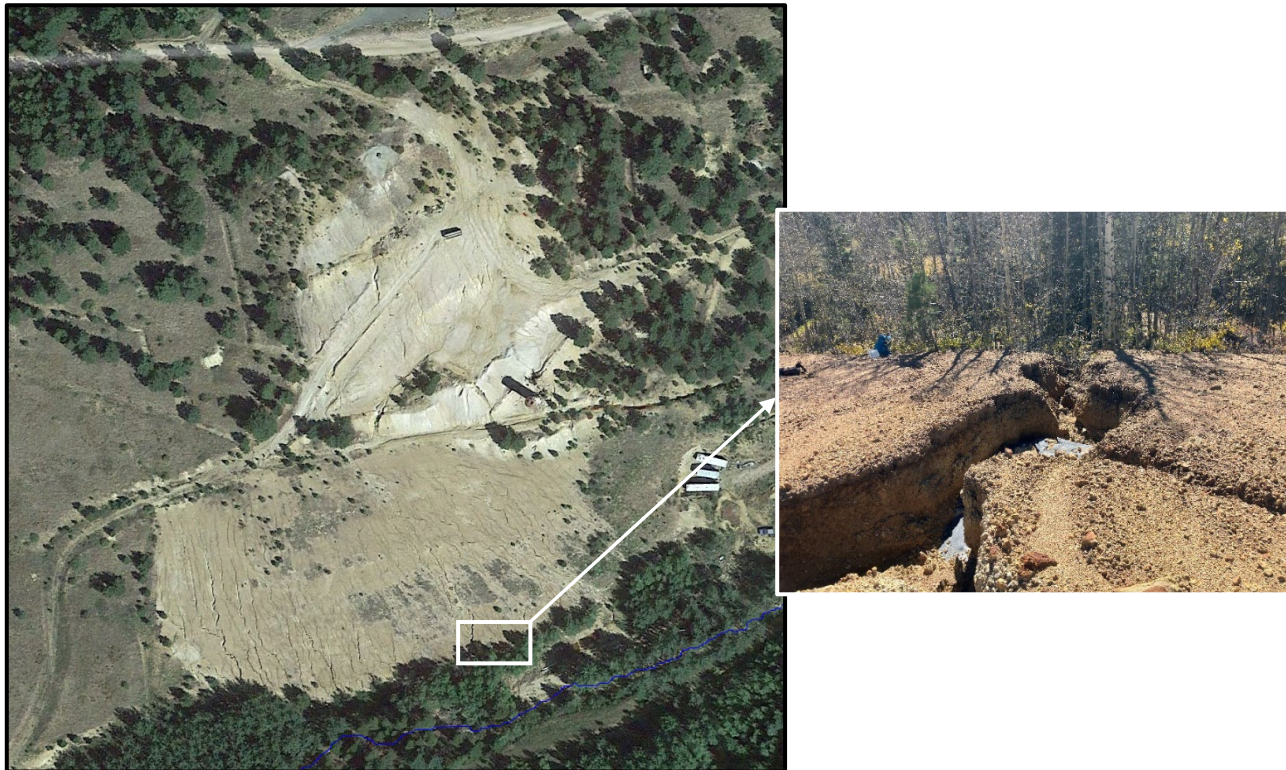
In the 2021 Russell Gulch Sediment Study, Site #136 was ranked as a top five priority bare area based on sediment contributions to the stream channel from hillslope erosion. The site is located upstream of Site #204 and is adjacent to and near the source of Willis Gulch. Two (2) samples were collected at Site #136. One (1) composite soil sample (136-MP-SO) was collected from the toe of the waste pile, and one (1) composite sediment sample (136-WGDS-SED) was collected from a cross section on Willis Gulch downstream of the waste pile and upstream of the confluence with South Willis Gulch.

Figure 8. Site #136 - Satellite imagery of the waste pile (with numerous rills and gullies) adjacent to Willis Gulch (left) and significant gully formation along the toe of the waste pile (right).

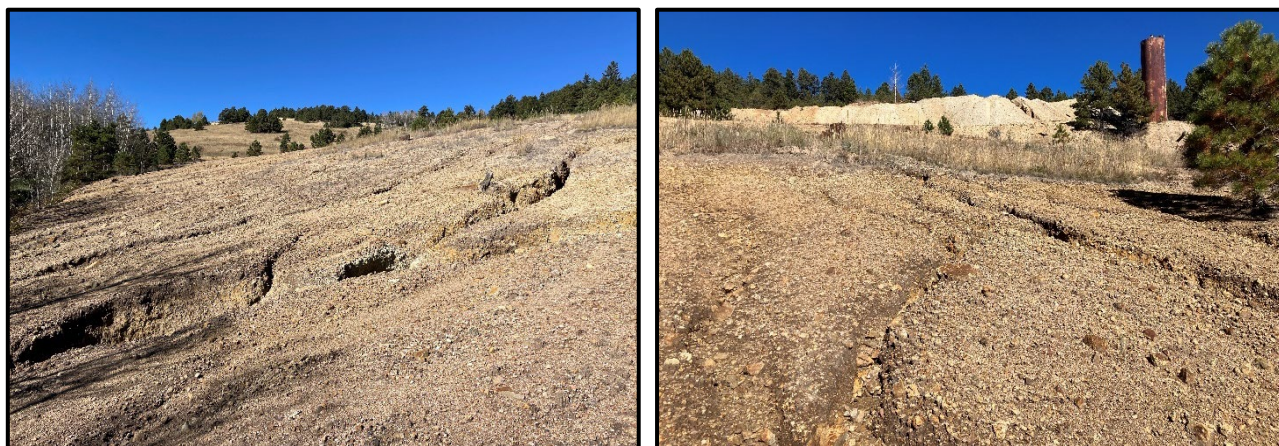
Figure 10. Site #136 - Rill erosion and gully erosion along the toe of the waste pile, looking upslope from left to right.

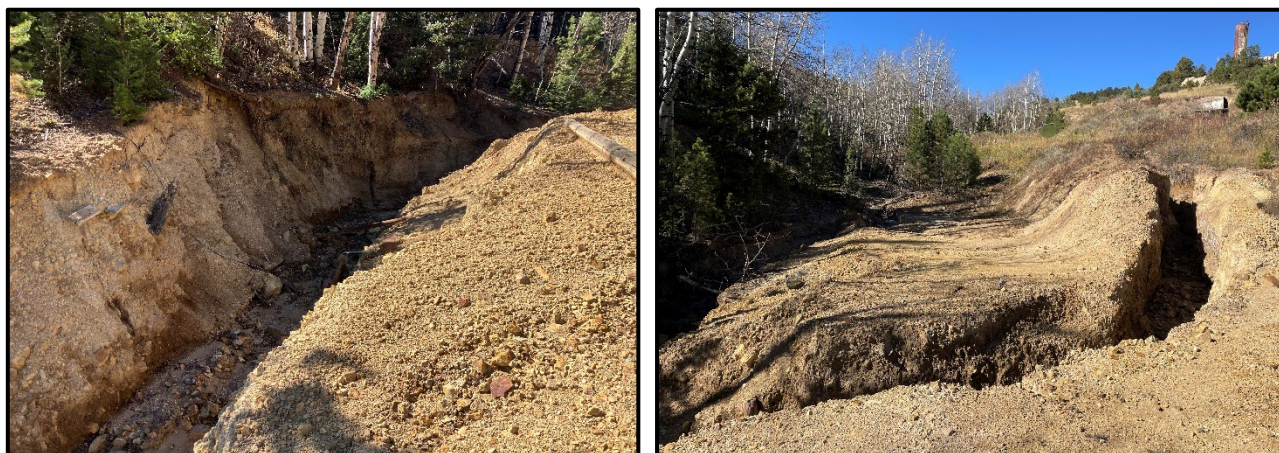
Figure 11. Site #136 - Channelized and incised section of Willis Gulch ~ 450 feet downstream of waste pile (left) and gully erosion of mine waste adjacent to Willis Gulch ~ 400 feet downstream of waste pile (right).

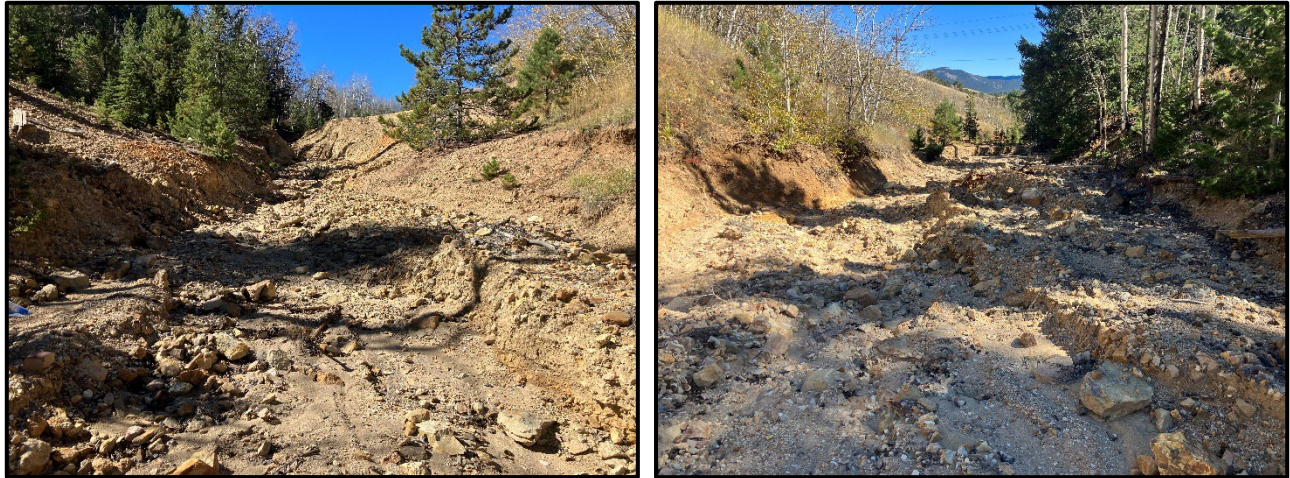
Figure 12. Site #136 - Willis Gulch sediment sample (136-WGDS-SED) location downstream of the waste pile, looking upstream (left) and downstream (right).

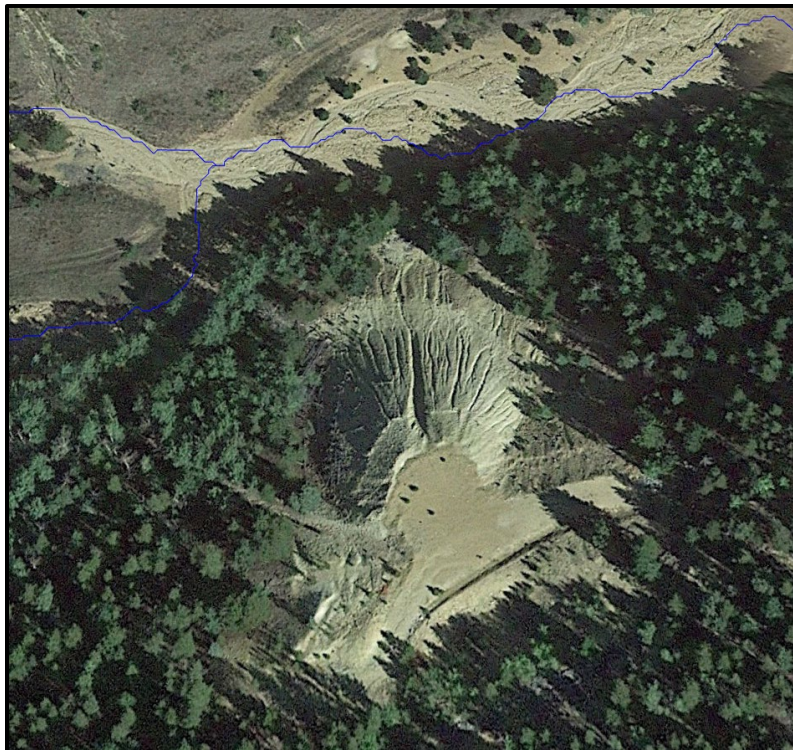
In the 2021 Russell Gulch Sediment Study, Site #204 was ranked as a top five priority bare area based on sediment contributions to the stream channel from hillslope erosion. The site is downstream of Site #136, upstream of Site #230, and adjacent to South Willis Gulch and Willis Gulch, with connectivity to Willis Gulch immediately below the confluence with South Willis Gulch. Two (2) samples were collected at Site #204. One (1) composite soil sample (204-MP-SO) was collected from the toe of the waste pile, and one (1) composite sediment sample (204-WGDS-SED) was collected from a cross section on Willis Gulch downstream of the waste pile and the confluence with South Willis Gulch.

Figure 13. Satellite imagery of the Site #204 waste pile (with numerous rills and gullies) adjacent to Willis Gulch and the South Willis Gulch confluence.

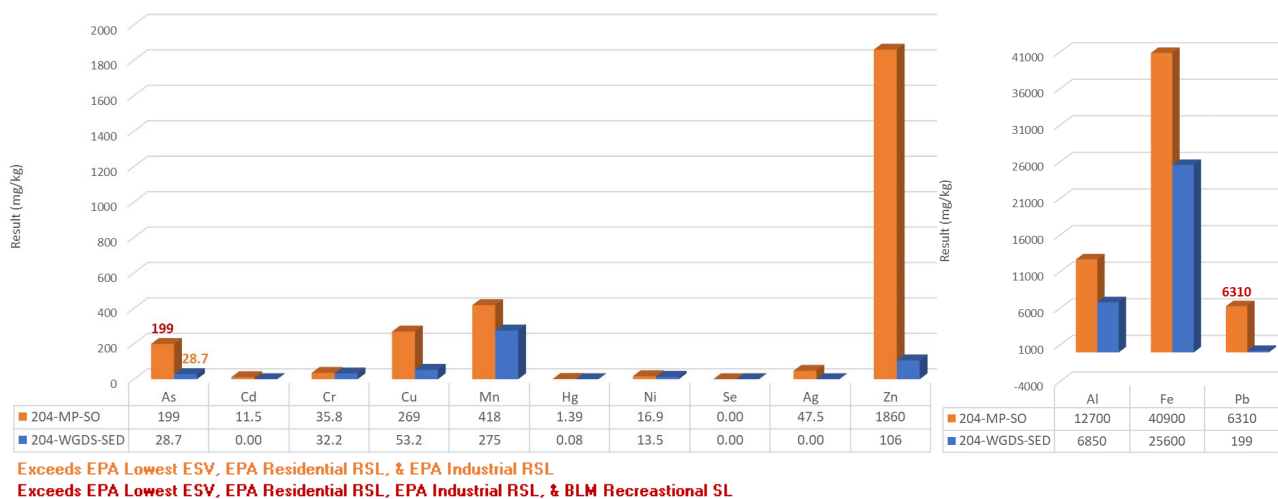
Figure 14. Site #204 – Total Metals

The waste pile (204-MP-SO) arsenic level was 293x the EPA Residential RSL, 66x the EPA Industrial RSL, and 6.5x the BLM Recreational SL, and the lead level was 15.8x the EPA Residential RSL, 7.9x the EPA Industrial RSL, and 7.9x the BLM Recreational SL. The waste pile at this site exhibited the 2nd highest arsenic concentration (199 mg/kg) and the highest lead concentration (6310 mg/kg) across all the sites sampled. The Willis Gulch (204-WGDS-SED) arsenic level was 42x the EPA Residential RSL and 10x the EPA Industrial RSL. *Overall, arsenic exceeded all three human health SLs at the waste pile site and two human health SLs at the Willis Gulch site, and lead exceeded all three human health SLs at the waste pile site (Figure 14).*

All twelve (12) of the metals detected *decreased* in concentration in the Willis Gulch sample compared to the waste pile sample, which may indicate limited mobilization of material from the waste pile to Willis Gulch, variable concentrations of metals across the waste pile, or dilution from other sediment sources to Willis Gulch that are either unimpacted or have lower concentrations of metals. Trees at the site (30-60' buffer zone) and previous restoration work (i.e., remnants of riprap stabilization along the base of the waste pile) are likely facilitating sediment attenuation and erosion reduction. However, it is apparent that sediment has breached the restoration feature and is migrating to the stream through a narrow, open area in the trees at the base of the waste pile. *Regardless, arsenic exceeded two human health SLs in Willis Gulch.*

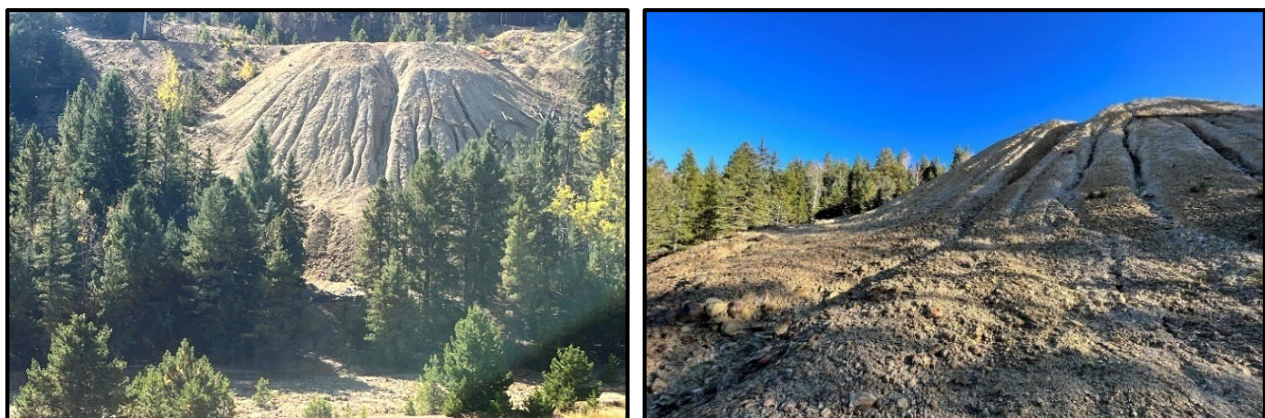
Figure 15. Site #204 - Looking south across Willis Gulch at the waste pile, with a view of the connectivity to Willis Gulch through the trees (left) and the northwest-facing slope of the waste pile (right).

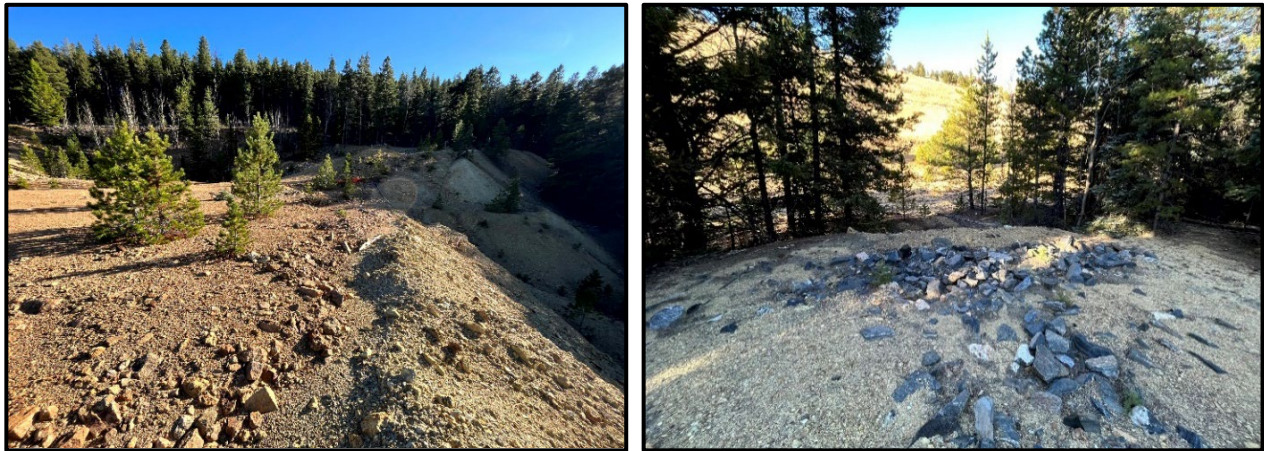
Figure 16. Site #204 – Looking southwest from the top of the waste pile (left) and the toe of the waste pile where sediment has breached a previously installed erosion control feature (right).

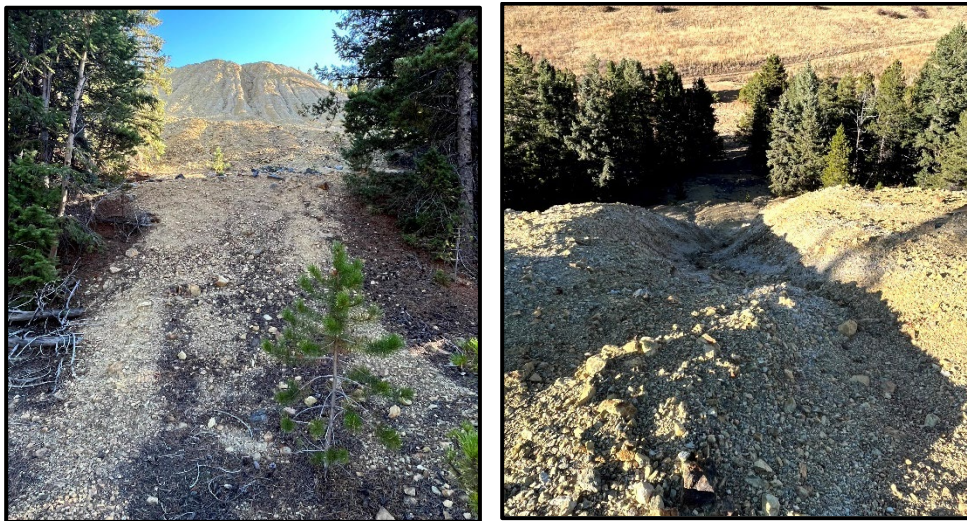
Figure 17. Site #204 - Looking upslope from Willis Gulch at the waste pile (left); note the sediment migration downslope below the previously installed erosion control structure. Looking downslope from the top of the waste pile (right); note the primary gully down the face of the waste pile, with connectivity to Willis Gulch.

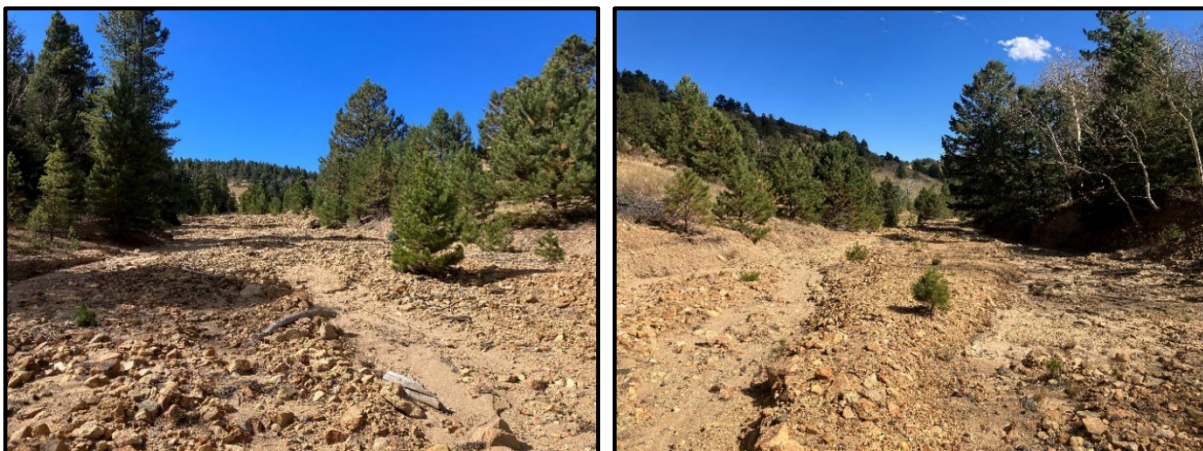
Figure 18. Site #204 - Willis Gulch sediment sample (204-WGDS-SED) location downstream of the waste pile, looking upstream (left) and downstream (right).

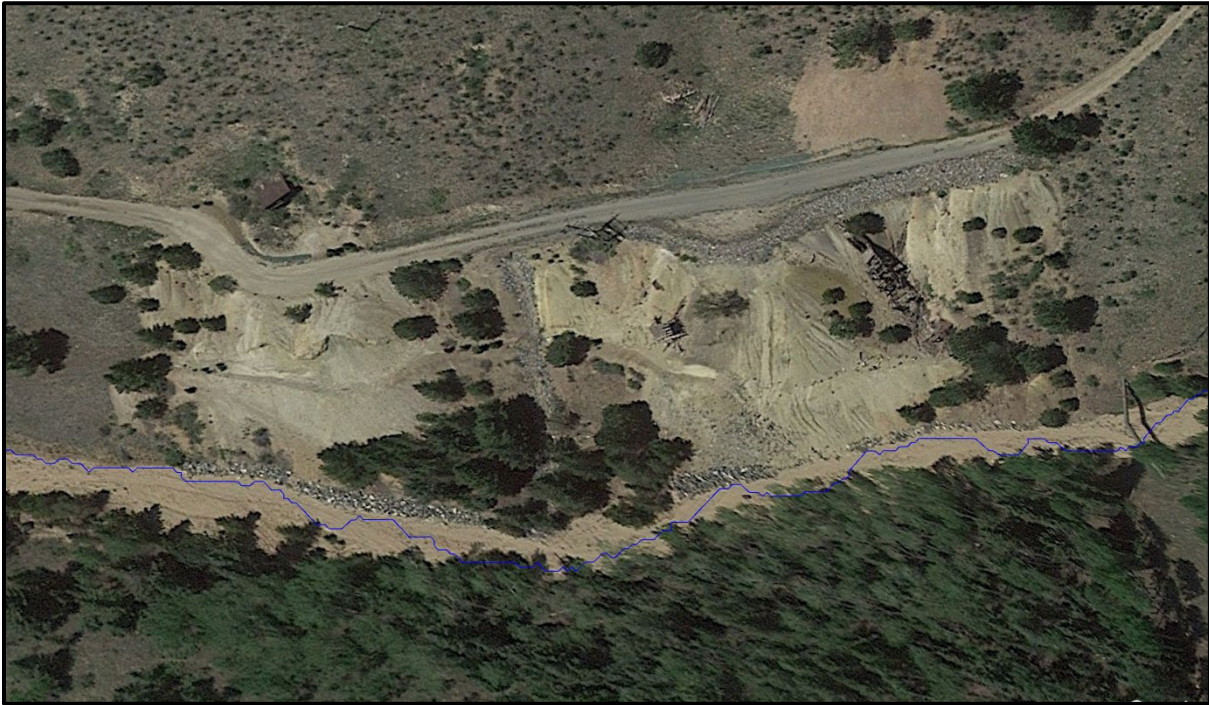
In the 2021 Russell Gulch Sediment Study, Site #230 was ranked as a top five priority bare area based on sediment contributions to the stream channel from hillslope erosion. The site is located downstream of Site #204, adjacent to Willis Gulch, and is the furthest downstream waste pile adjacent to Willis Gulch before merging with Russell Gulch. Two (2) samples were collected at Site #230. One (1) composite soil sample (230-MP-SO) was collected from the toe of the waste pile, targeting areas with connectivity to Willis Gulch, and one (1) composite sediment sample (230-WGDS-SED) was collected from a cross section on Willis Gulch downstream of the waste pile and upstream of the confluence with Russell Gulch.

Figure 19. Satellite imagery of the Site #230 waste pile (with numerous rills and gullies visible at the eastern portion) adjacent to Willis Gulch, ~ 700 feet upstream of the confluence with Russell Gulch.

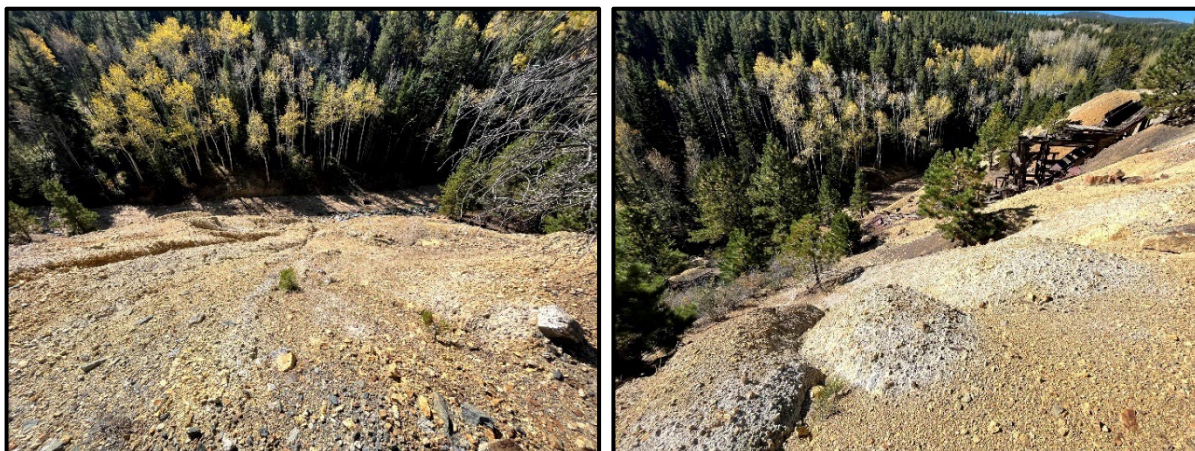
Figure 21. Site #230 – Steep slopes with Willis Gulch at the base, rill erosion and gully erosion, and an old mining structure.

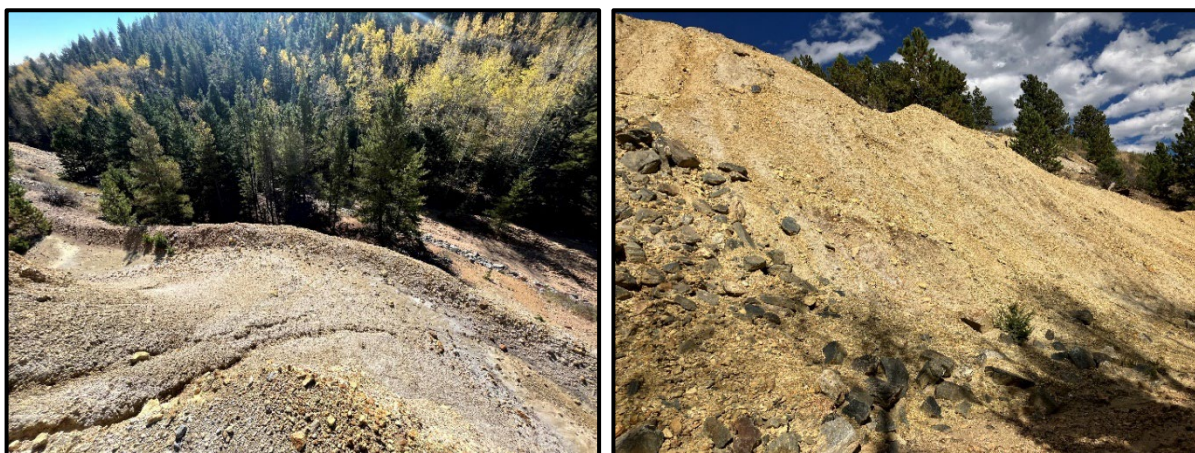
Figure 22. Site #230 – Rill erosion with a previously constructed berm that appears to be capturing runoff and limiting sediment transport to Willis Gulch (left) and the base of the waste pile where sediment flows directly into Willis Gulch (right).

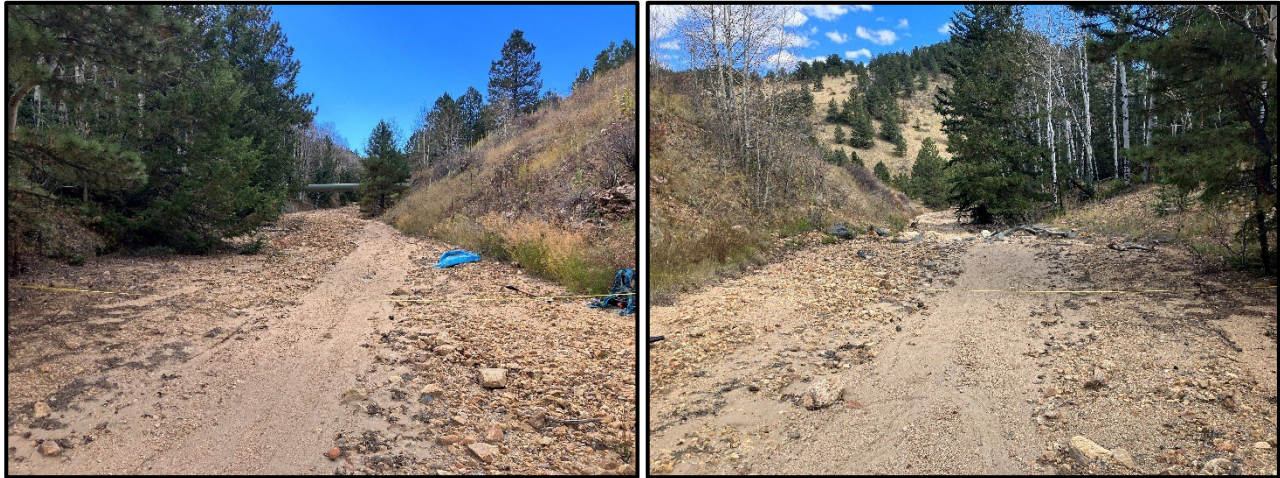
Figure 23. Site #230 - Willis Gulch sediment sample (230-WGDS-SED) location downstream of the waste pile, looking upstream (left) and downstream (right).

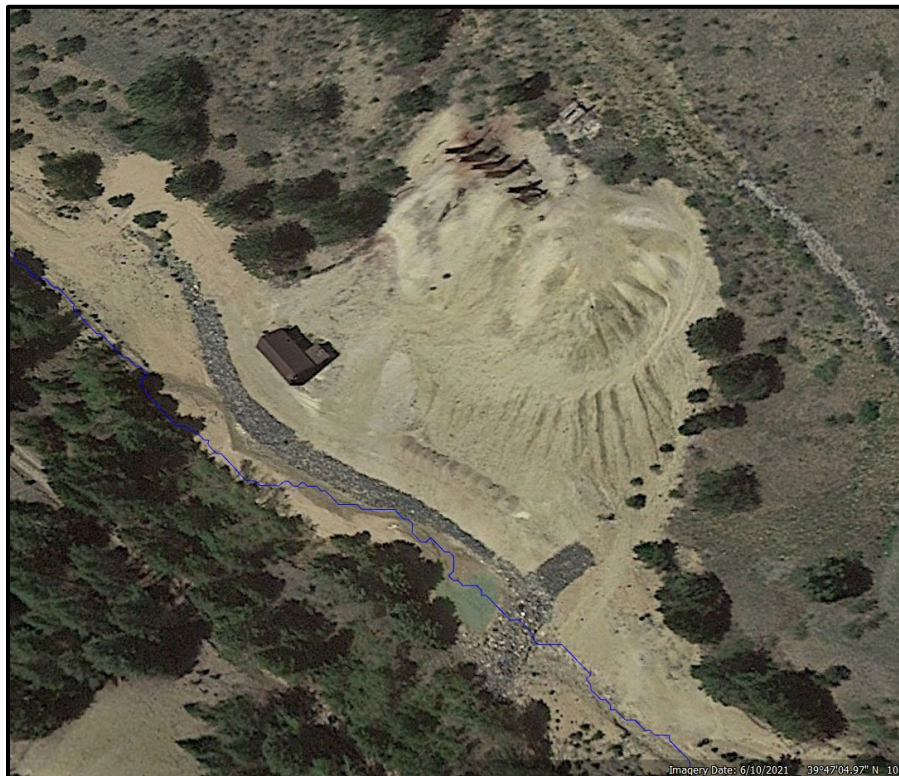
In the 2021 Russell Gulch Sediment Study, Site #158 was ranked as a top five priority bare area based on sediment contributions to the stream channel from hillslope erosion. The site is adjacent to Russell Gulch and is the furthest downstream waste pile adjacent to Russell Gulch before merging with Willis Gulch. Two (2) samples were collected at Site #158. One (1) composite soil sample (158-MP-SO) was collected from the toe of the waste pile, targeting areas with connectivity to Russell Gulch, and one (1) composite sediment sample (158-RG-SED) was collected from a cross section on Russell Gulch partially downstream of the waste pile (i.e., immediately upstream of the sediment trap installed in the channel adjacent to Site #158) and upstream of the confluence with Willis Gulch. The primary connectivity to the stream occurs at the southeast side of the waste pile, where sediment is being transported downslope via gully erosion. Where the sediment was sampled, there appears to be minimal connectivity with the waste pile due to sediment attenuation and erosion control achieved by the riprap toe stabilization installed along the base of the waste pile. TU chose the sediment sample location based on the significant sediment accumulation at the sediment trap, which could represent sediment transported downstream from numerous other AML sites adjacent to Russell Gulch upstream of Site #158.

Figure 24. Satellite imagery of the Site #158 waste pile (with numerous rills and gullies) adjacent to Russell Gulch.

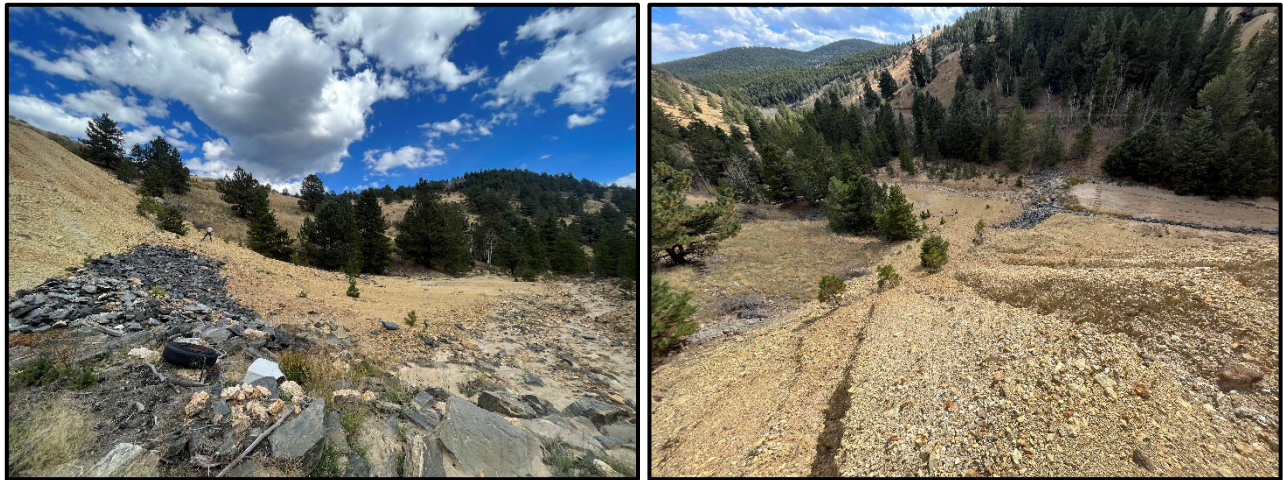
Figure 26. Site #158 – The base of the southeast portion of the waste pile where sediment flows directly into Russell Gulch (left) and the origination point of that sediment from the top of the waste pile where there’s significant gully erosion (right).

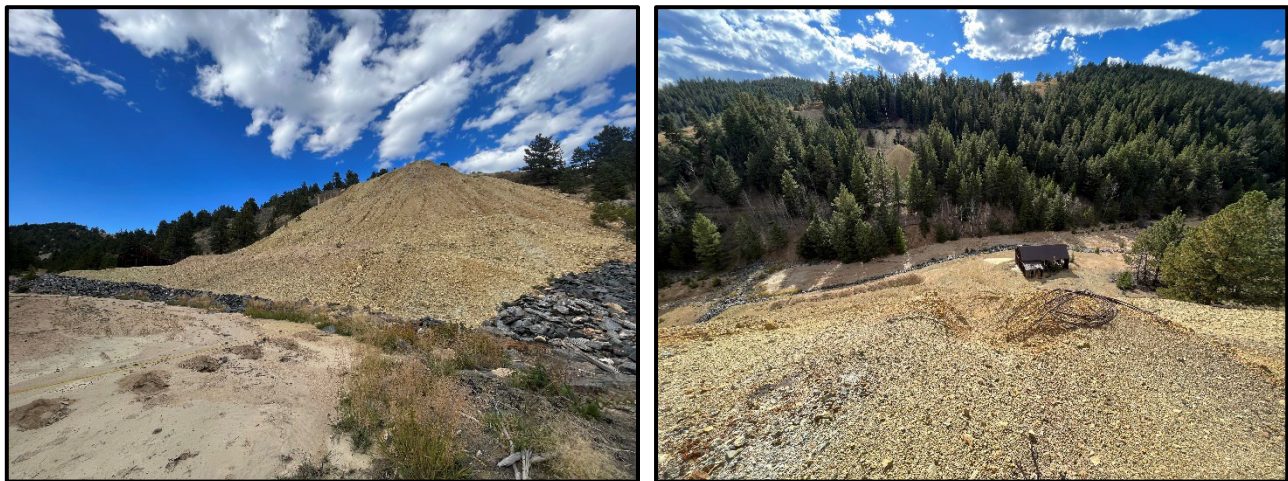
Figure 27. Site #158 – The southeast corner of the previous riprap stabilization work (left) and a downslope view of the southwest-facing slope of the waste pile with Russell Gulch and a historic mine structure at the base (right).

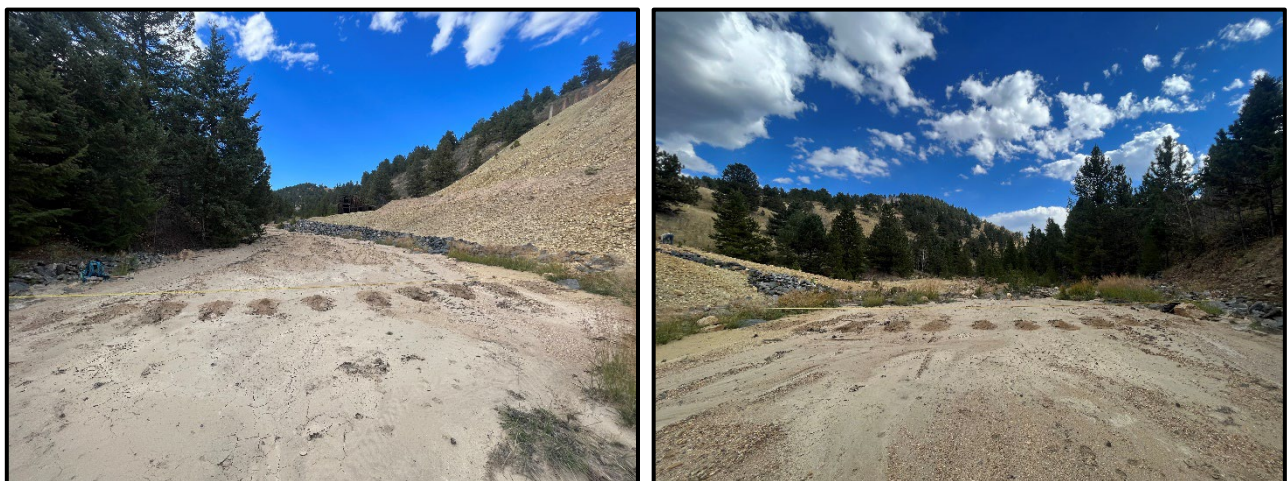
Figure 28. Site #158 – Russell Gulch sediment sample (158-RG-SED) location, partially downstream of the waste pile, looking upstream (left) and downstream, where the in-channel sediment trap is located (right).

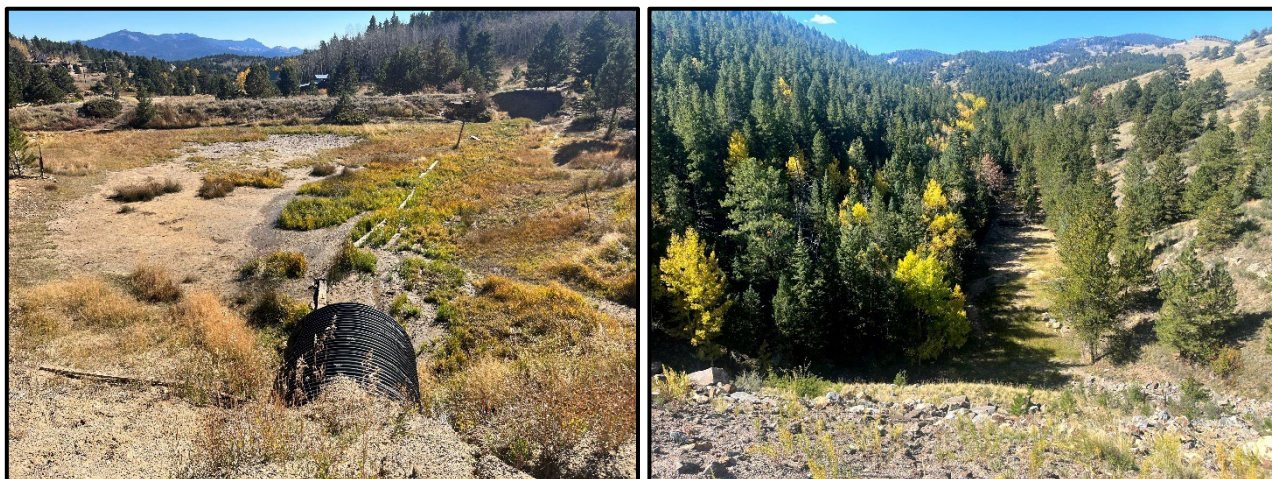
Figure 30. Brackets – Upstream Russell Gulch sediment sample (UPS-RG-SED) cross section, looking downstream (left) and looking upstream at the Russell Gulch drainage from the Central City Parkway (right).

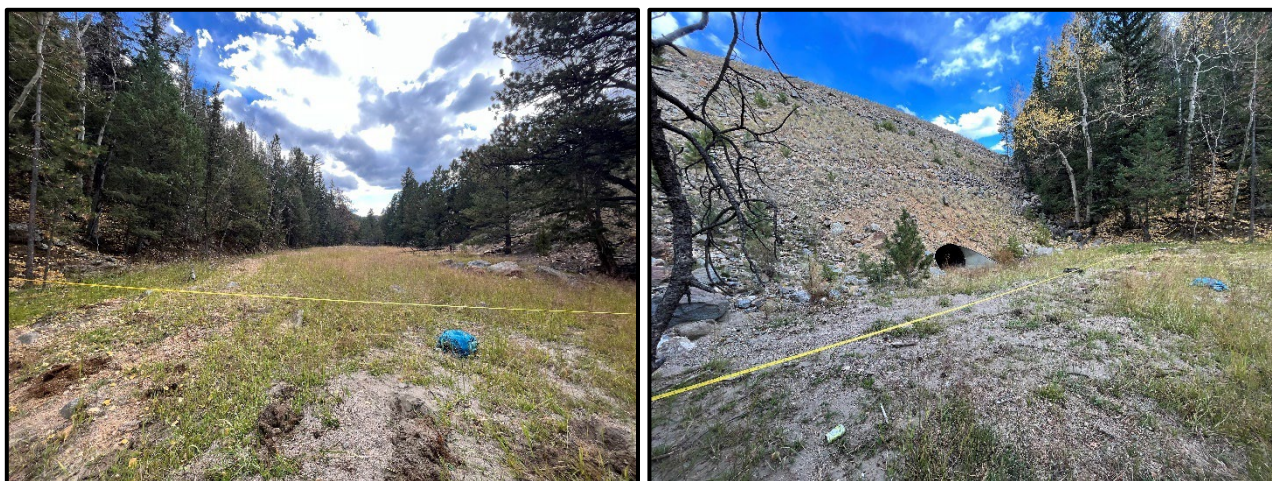
Figure 31. Brackets – Downstream Russell Gulch sediment sample (DWS-RG-SED) cross section, looking upstream (left) and looking downstream towards the Central City Parkway culvert (right).
