# **Final Design Report**

## **Beaver Habitat Development**

*Clear Creek Watershed & Forest Health Partnership*

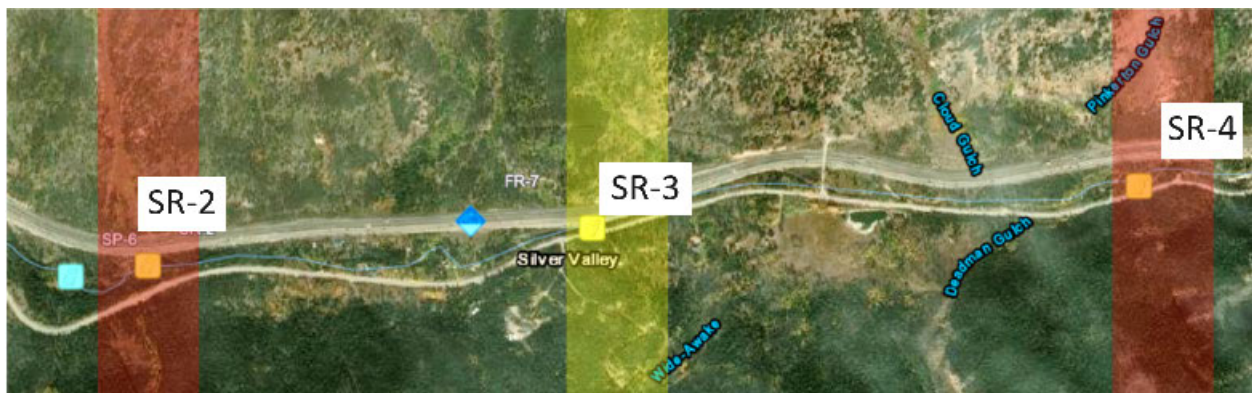
**Figure 1.1** Map of the three zones of interest as stated by the Upper Clear Creek Watershed Pre-Wildfire Planning Study. The zone on the far left was identified as our working site.

The project takes place along the mainstem of Clear Creek in Colorado in a roughly 3.5-mile stretch between Bakerville and Silverplume along the Colorado I-70 expressway. Three zones within this stretch of Clear Creek have been identified in the [Upper Clear Creek Watershed Pre-wildfire Planning Study](#) completed by Matrix Design, Inc. as critical locations for low-impact stream development. The proposed areas are prone to wildfires and post-wildfire flooding and would benefit from stream restoration efforts. The stream lies in the valley of the Clear Creek watershed and is constrained between two roadways on either side. The creek has significant variability in channel characteristics along the proposed sites, showing higher flow in pinched areas and low flow in wider sections. The most viable site for stream restoration was determined to be the westernmost location (39°41'38.2" N 105°47'08.9" W), SR-2, due to it possessing the necessary room for expansion of the floodplain and its lack of an existing beaver population. The site is well-wooded with aspen which is also necessary for beaver introduction.

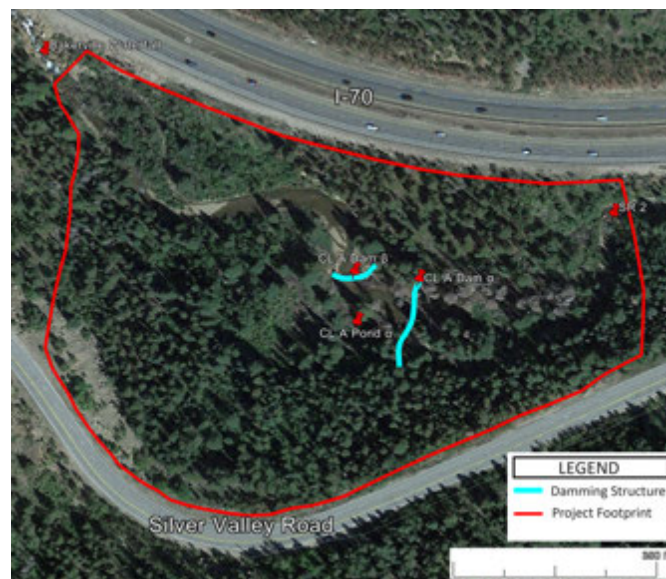
**Figure 1.4** Project Footprint, New Dam Outlines, and New Pond

In August of 2023 the site was revisited and it was found that beaver activity in the area had increased dramatically. Heavy rain in the early summer months had changed aspects of the stream's flow patterns; an abundance of beaver fallen trees also impacted the flow dynamics in the area. Beaver activity that was previously half a mile downstream had since moved into the area. Beaver activity within the site boundaries has expanded to two separate dams, a check dam denoted as Colony A Dam Beta (*CL A Dam β*) and a main dam denoted as Colony A Dam Alpha (*CL A Dam α*) as well as a beaver lodge which are represented in Figure 1.4. The beavers took it into their own small hands, building a roughly 160-foot wide dam, named Colony A Dam α, 500 feet upstream from our initially selected site (SR-2). The dam raises the water almost 8 feet above the existing stream and creates a pond, named Colony A Pond α, that spans more than an acre and averages at least 1 foot deep throughout, in some places getting as deep as 6 feet. Just slightly upstream of Dam α is another, older, structure which we will call Colony A Dam β. According to some local fishermen we spoke with, this dam has been around for about 5 years. However, this dam is much less structurally sound than Dam α, and currently only serves as a check dam of sorts, filtering larger debris from getting into the newly developing Pond α. The entire area of interest and the respective coordinates are outlined in Figure 1.5.

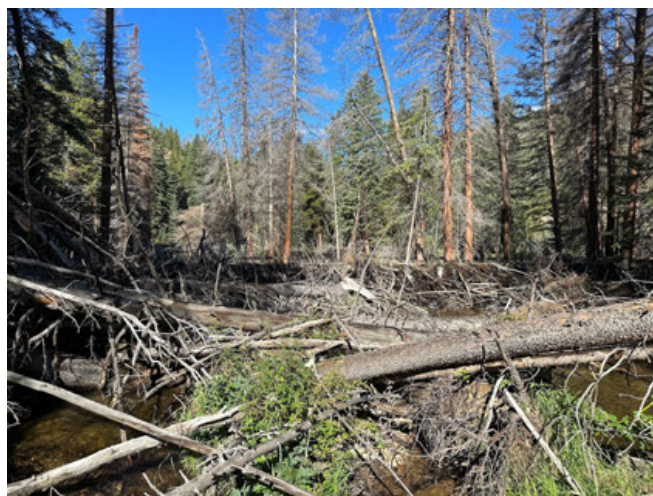
**Figure 1.7** Dam  $\alpha$  October 17, 2023

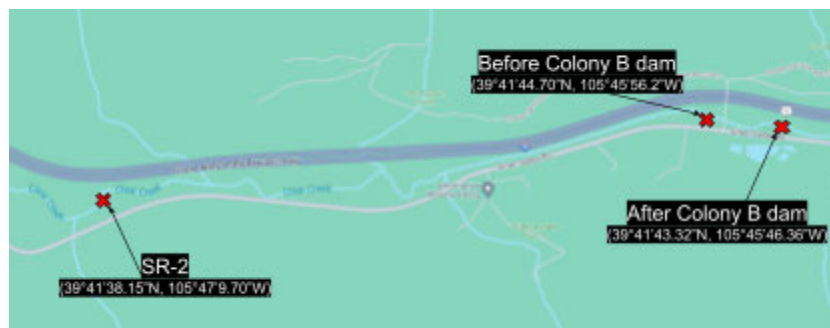
**Figure 3.3** Initial Water Test Sites

In addition to surveying our site, we also collected water quality samples to analyze the potential effects of our project on the stream's chemistry. Samples were taken in bottles and delivered to the City of Golden water testing lab. These samples were analyzed for turbidity, hardness, alkalinity, and dissolved metal content. Additionally, equipment borrowed from the Colorado School of Mines included a water flow meter to determine the volume flow rate of the creek upstream of the dam, precise values for pH, and dissolved oxygen. Initially, 3 locations were selected for testing surrounding another existing beaver habitat, Colony B, and at our originally selected site, SR-2, as a test subject to observe any differences caused by beaver damming.

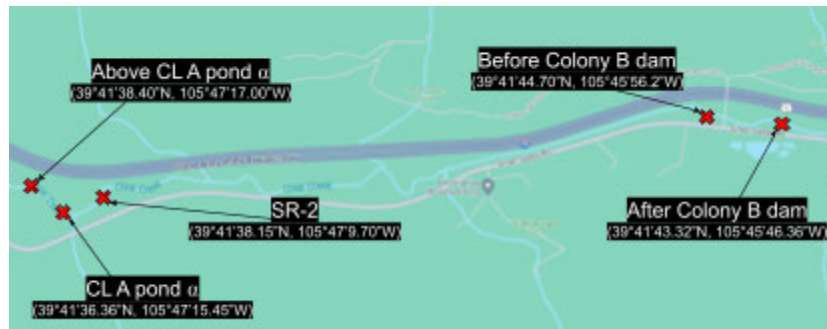
**Figure 3.3** Fall 2023 Water Test Sites

After returning from summer break we returned to our site to survey and found the newly established CL A Dam  $\alpha$  and Pond  $\alpha$  which we could now test as its location was much closer to the originally desired location. For our next round of testing, we maintained our 3 original test locations in order to compare with our first round of collection as well as adding two new locations. One in the channel leading up to Pond  $\alpha$  and another in Pond  $\alpha$ . Our original test site at SR-2 acted as an after dam site being only 500 ft downstream of Dam  $\alpha$ .

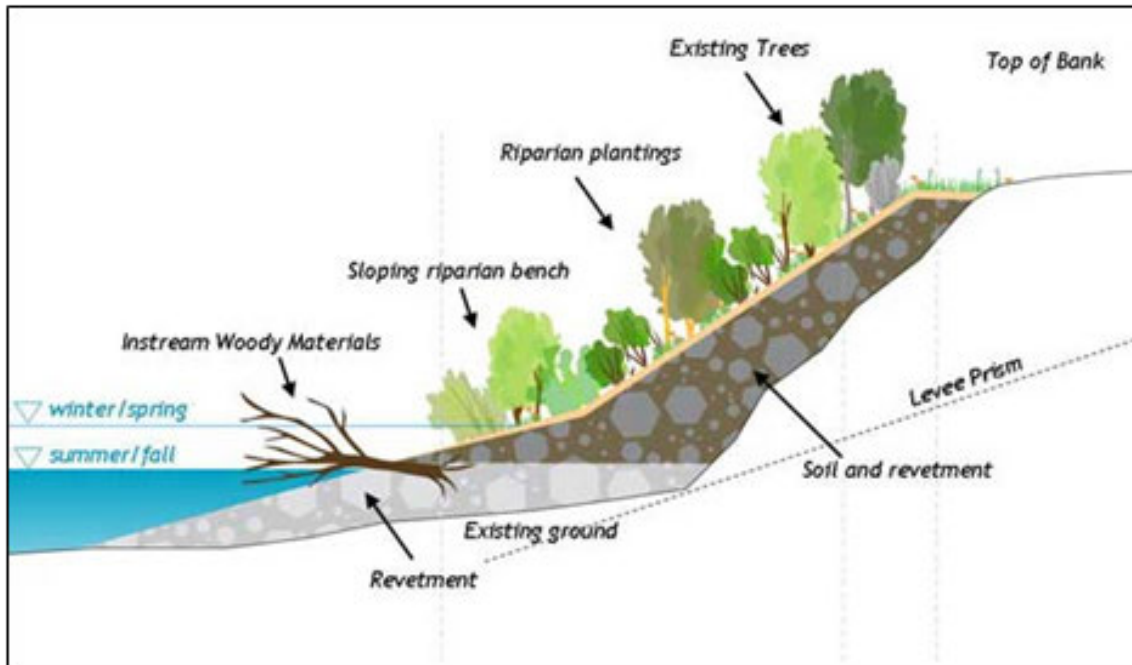
**Figure 4.1** Example Riparian Revegetation Plan

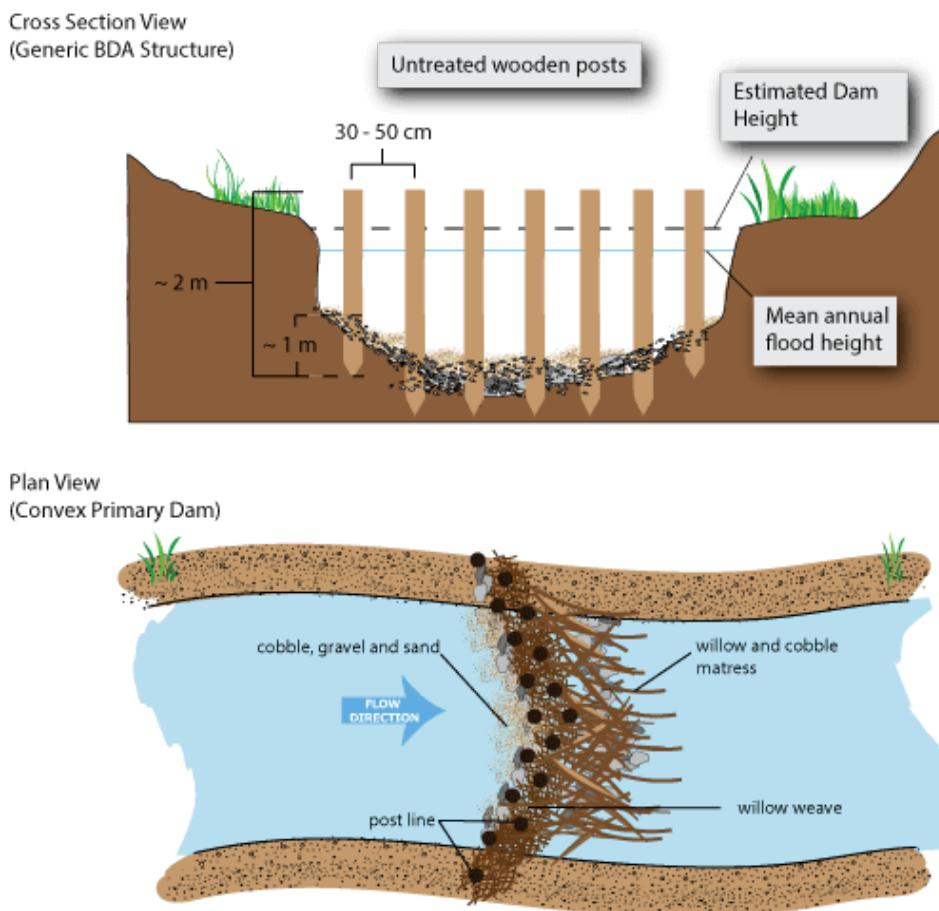
**Figure 4.4** BSS Cross Section and Plan View

These are a manmade structure designed to mimic beaver activity. They utilize woody debris in order to pond the flow and act as a dam. This will encourage beaver activity near these dams. Beavers will often continue to build upon BSSs, reinforcing with more wood and mud, increasing their seal and improving functionality. These structures are often catalysts for habitat expansion and complex development. BSSs tend to be cost-effective compared to other stream restoration techniques. Installment costs range around \$2,000-\$5,000. This is a direct result of promoting increased beaver activity and allowing nature to complete the work for us.

We tested two different possible spots to add a BSS. The first being at SR-2. When calculating the volume retained from adding a BSS, we found that there would be no significant increase of water storage at this location. This is because the slope from Colony A, Dam  $\alpha$  to SR-2 changes rapidly, requiring an outrageously wide dam to keep water from going around it and negating any

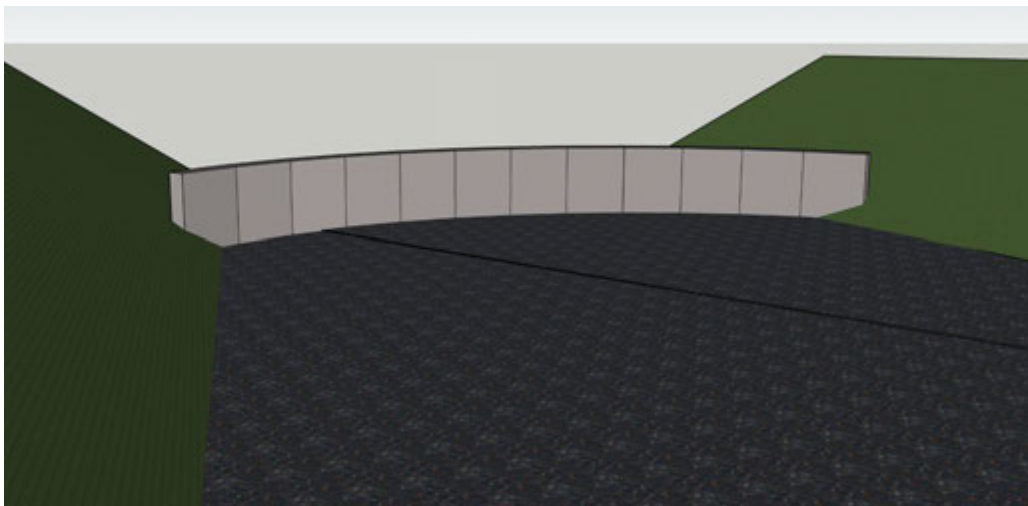
**Figure 4.7** CAD Rendered Potential Human-Made Dam

The pre wildfire planning study proposed a man made, concrete dam in place of the recently developed beaver dam that now exists on our site. The study proposed an 18ft high dam across the stream cross section that would reach nearly up to the elevation of Interstate 70. This dam would allow for the absolute maximum water storage for our project site at about 21 acre ft of volume, with 4.41 acres of area available to work with. This is by far the most extreme measure proposed as an alternative to revegetation and leaving the beavers to do the work. At the very least, an access road would need to be built from Silver Valley Rd down to the stream in order to bring heavy equipment to the site. Additionally, flooding risks would be extremely high; the water level of the pond would be very close to running off onto I-70, and the downstream risks from a dam failure would be far more considerable and destructive.

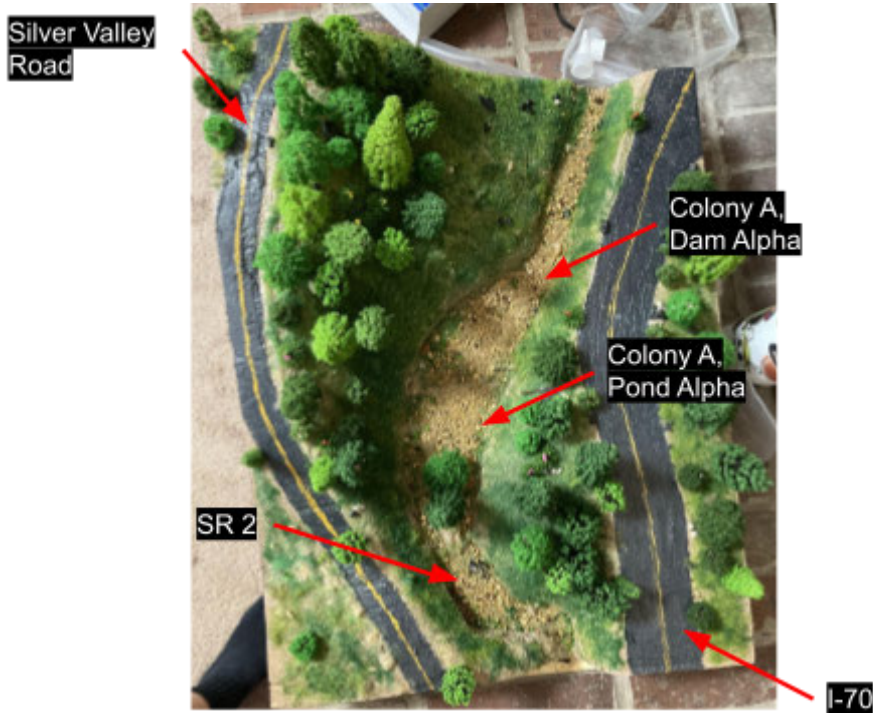
**Figure 5.1:** Top View of Model, With Labels

This is a 1:600 horizontal, 1:120 vertical scaled model of SR2, Colony A Pond  $\alpha$ , and Colony A Dam  $\alpha$ . A pump will be attached to the west side of the model to simulate water flow. Two dams have been created (not shown), one made of sticks to simulate a beaver dam and one made of cardboard to simulate a human made structure.

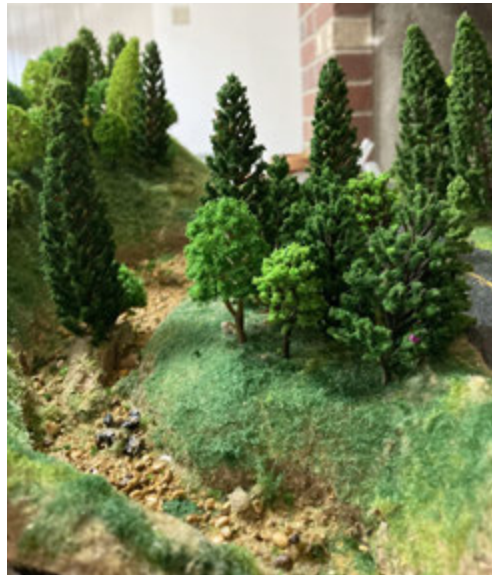
**Figure 5.2:** Side View of Model - From SR 2

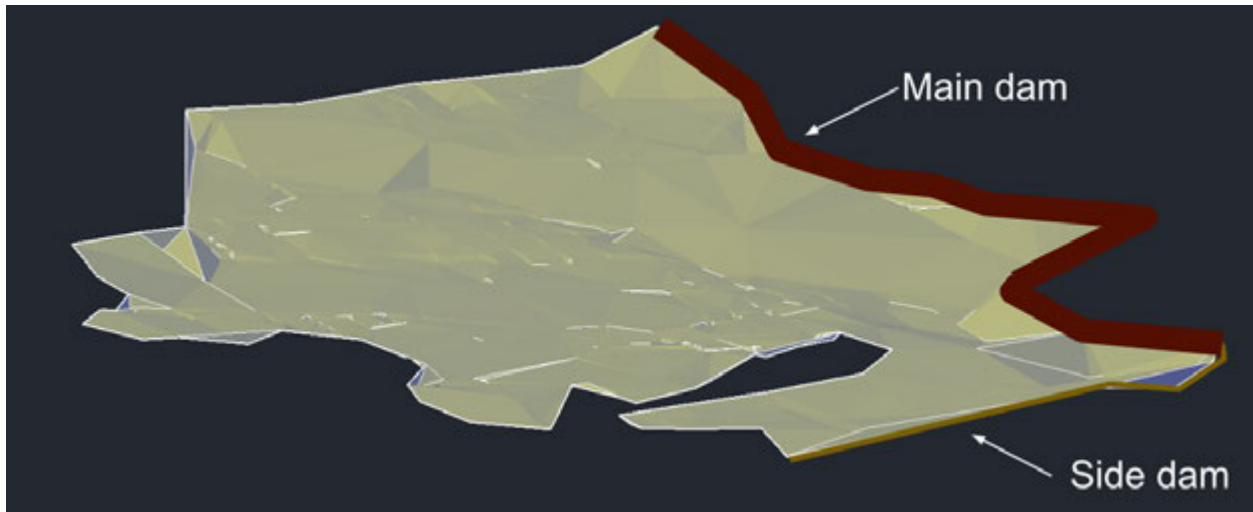
**Figure A.1:** Civil3D Rendered Surface of Pond  $\alpha$ , Side Profile

From there, we have continued our analysis of the site in Civil 3D and HEC-RAS. During the survey, our strategy was to collect points along the existing shoreline, so that the pond could be built in Civil 3D, and a volume could be found. In Civil 3D, we overlaid our survey points collected in the field on top of LiDAR data collected by the Colorado Water Conservation Board via the Colorado Hazard Mapping & Risk MAP Portal [3] to create a surface of our site. From this model, we found a volume for the newly developed Pond  $\alpha$ , Pond  $\square$ , Pond  $\square$ , and attempted to create a file which could be translated to HEC-RAS for flow modeling.

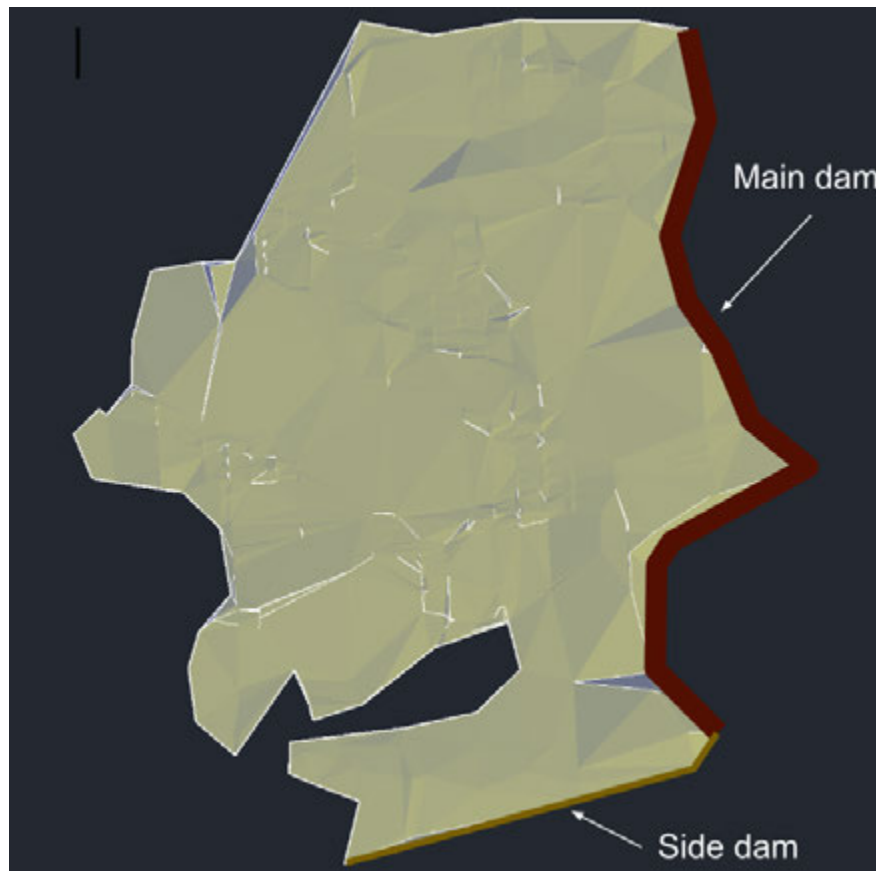
**Figure A.2:** Civil3D Rendered Surface of Pond  $\alpha$ , Top View
