Final Design Report:

Missouri Creek & North Clear Creek Stream Restoration and Wildfire Prevention

Stream Team: Group 33

November 2022

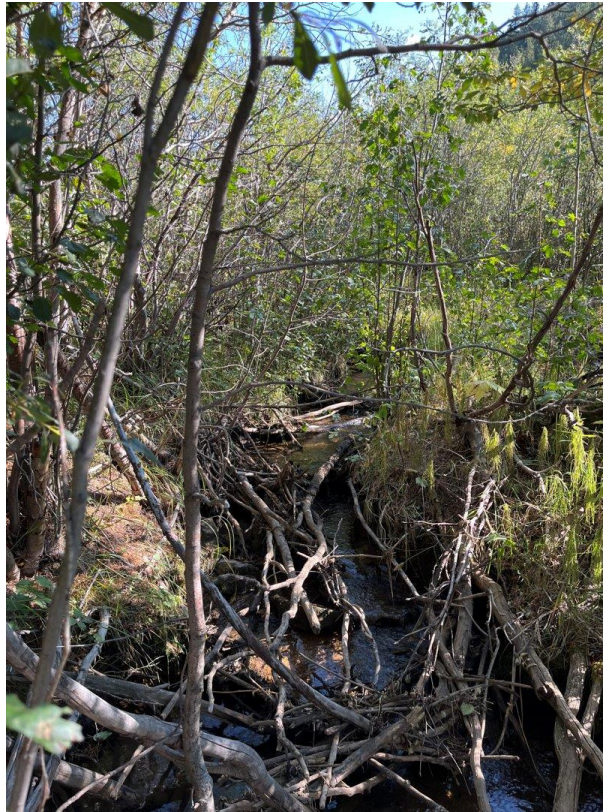
Figure 1. Missouri Creek obstructed with dense trees

Overall, the Missouri Creek river needs to be less obstructed (Figure 1). Another proposed solution would be to take the dead logs perpendicular to the river and put them on the side of the stream bank (Appendix 2A). This would also help reinforce the bank so less erosion occurs, and less sediment gets deposited into the creek. Missouri Creek and North Clear Creek also need to be deepened for trout to prosper more [3]. The first step to this process would be to remove dead, obstructive, plants and wood material from the river and then reinforce the side of the stream bank with that matter. After this occurs, there would a higher flowrate in the creek to wash excess

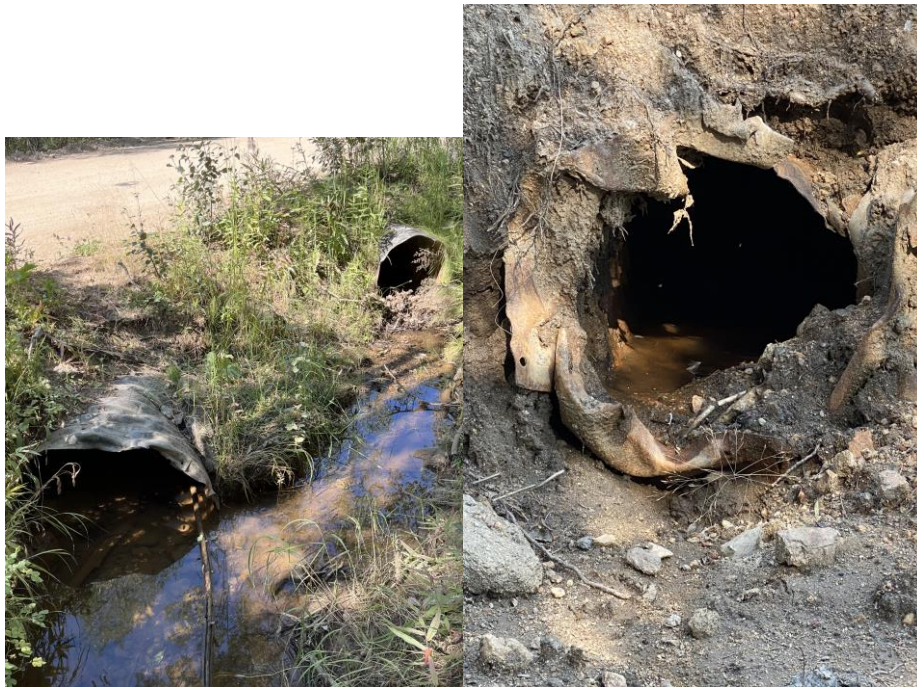
Figure 2 & Figure 3. Current culverts at the upstream section of Missouri Creek off Missouri Creek Road

At the upstream part of the creek, there are outlet culverts that are caved-in and need replacement (Figure 2 and Figure 3). These calculations are still a work in progress, but drawings of what the updated culvert pipes should look like are shown in Appendix 3A. The team is also looking into who owns the rights to the culvert replacement since they are on the boundary between the Forest Service and Gilpin County. At the last site visit, a sign was discovered that indicated the Forest Service owned the land upstream of the pooling pond. It would be necessary to reach out and confirm before replacement occurs.
