Upper Clear Creek Watershed Plan Update

Upper Clear Creek Watershed Association
April 2014

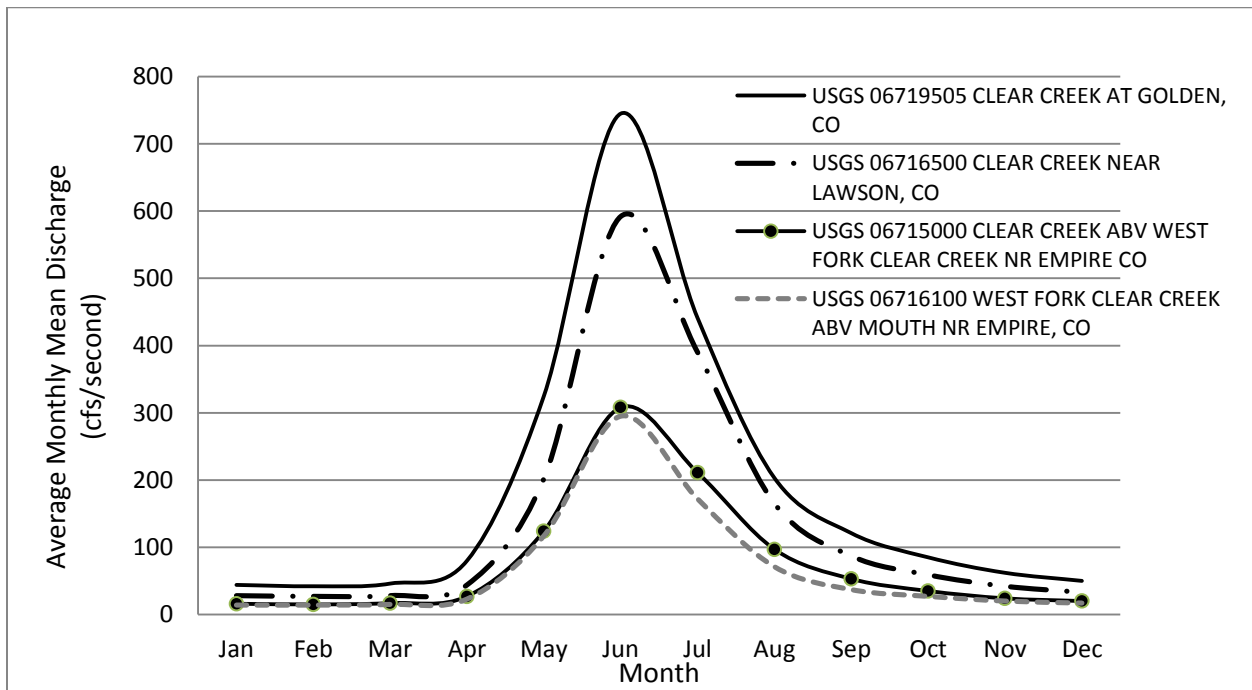
Figure 2-2: Avg. Monthly Discharge for USGS Gaging Stations on Clear Creek, CO

Low flows are particularly important for quantifying water quality impacts. During the low flow months, flow along Clear Creek is much less varied from the upstream reaches near Georgetown to the downstream reaches near Golden. As seen in Figure 2-2 above, average monthly low flows occur between the months of October and April. Near Empire, low flow varies from about 15 cfs to 35 cfs. Near Lawson, the average monthly low flows vary from approximately 30 cfs to 60 cfs. When Clear Creek reaches Golden, low flows vary from approximately 40 cfs to 80 cfs.

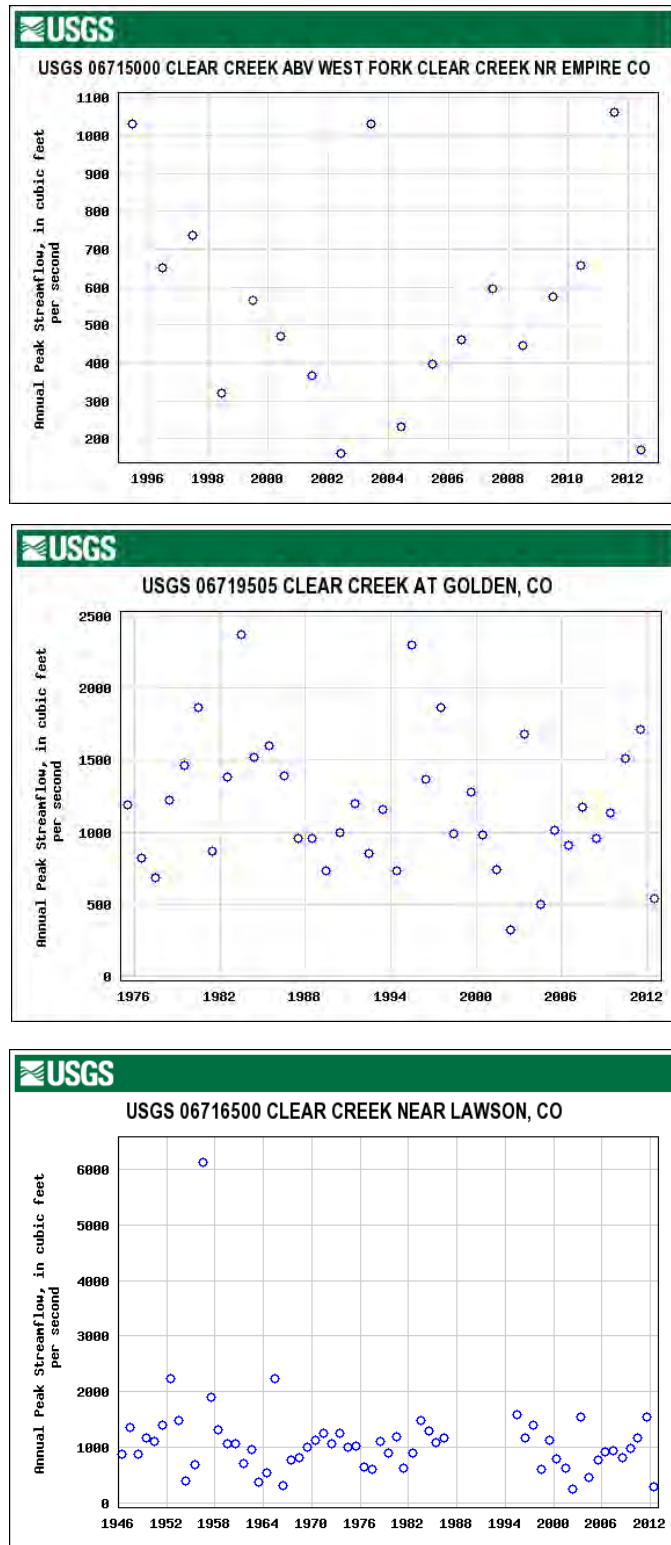
Figure 2-3: Clear Creek Streamflow at USGS Gages - Annual Peak Streamflow

USGS annual peak streamflow data show annual peak flows in Figure 2-3 at three locations along Clear Creek. Table 2-2 summarizes the maximum annual peak streamflow data. Peak flows in 1983 and 1995 exceeded 2,300 cfs in Golden. For the 59 year period of record, the USGS gage near Lawson, CO indicates one major peak on Clear Creek in June 1956 with a flow rate of 6,130 cfs. Other gages on Clear Creek do not indicate any other major peak streamflow trends in their more recent and shorter periods of record. Using the Lawson gage as an indicator, there have not been any significant floods on Upper Clear Creek in recent years.

Flows in Clear Creek can be impacted by droughts due to low winter snow accumulation. The two lowest peak stream flows on record at the Lawson gage, 252 and 302 cfs, occurred during the 2002 and 2012 droughts, respectively; the peak streamflow during the 1977 drought was 610 cfs. The graphs of annual peak streamflow in Figure 2-3 illustrate the highly variable flow conditions experienced in Clear Creek from year to year with 2011 flows 4 to 5 times greater than 2012 as measured at the Golden gage 06719505.

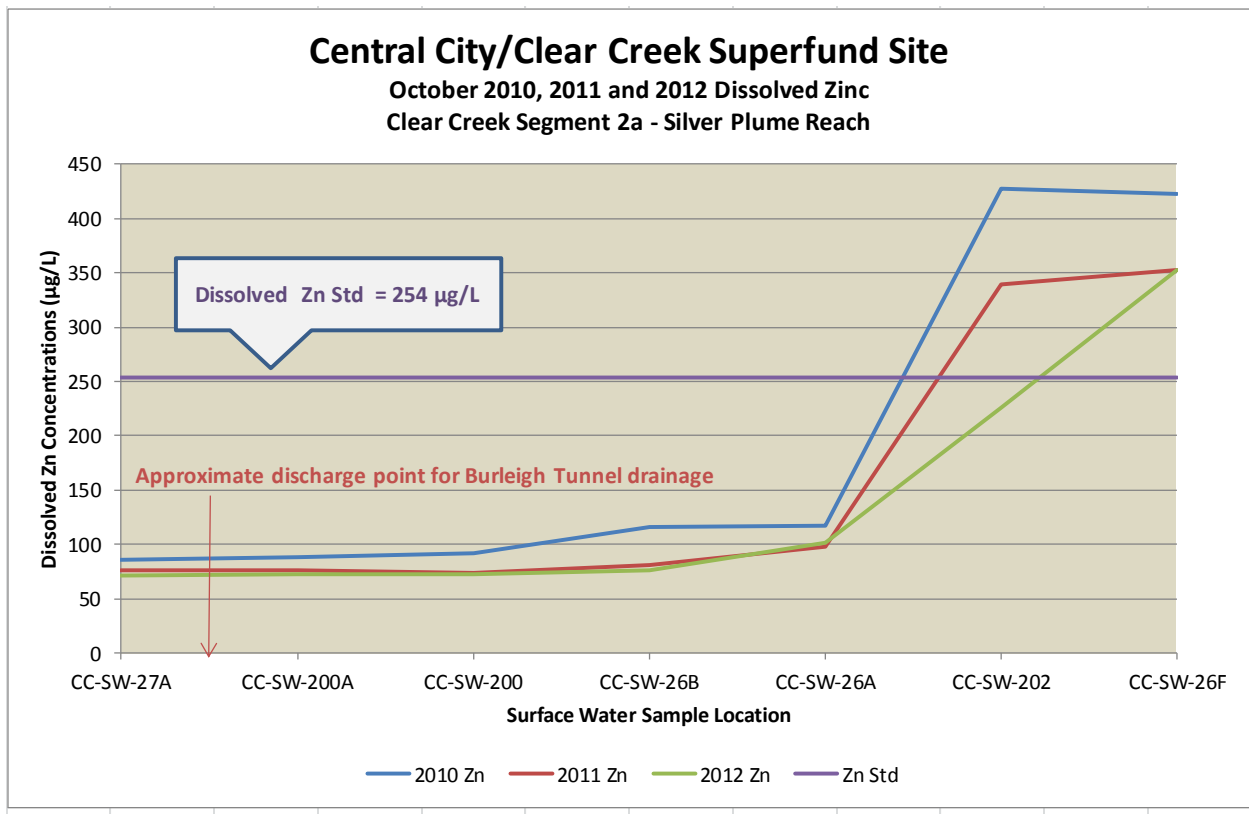
Figure 4-1: Dissolved Zinc in Clear Creek Silver Plume Reach

Passive remediation of mine drainages similar the Burleigh Tunnel indicate it may be possible to remove 85% to 95% of the zinc in shallow Silver Plume groundwater using newer proven treatment techniques that require fairly infrequent, low-level maintenance. The feasibility of such passive remediation should be re-evaluated for the groundwater contamination in the Silver Plume area. If such treatment looks promising, a new passive groundwater treatment system should be constructed to prevent this nonpoint source problem from worsening.

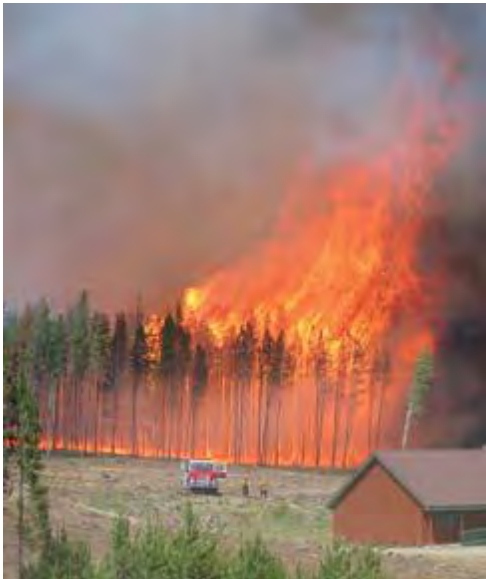
Figure 4-2: Source: Clear/Bear Creek Wildfire/Watershed Assessment (JWA, 2013)

The three factors (1. wildfire hazard, 2. flooding and debris flow, and 3. soil erodibility) are used to create a composite hazard ranking for each sixth-level watershed. The study evaluated wildfire hazard based on spatial data including forest density, vegetation type, and mountain pine beetle-kill. Wildfire hazard is based on the output of flame length expected in each watershed.

Hazard potentials related to flooding and debris flow were evaluated on watershed slope and road density. Watersheds with steeper slopes tend to generate greater debris flows after a wildfire; and watersheds with greater road densities are more sensitive to higher peak flows following a wildfire.

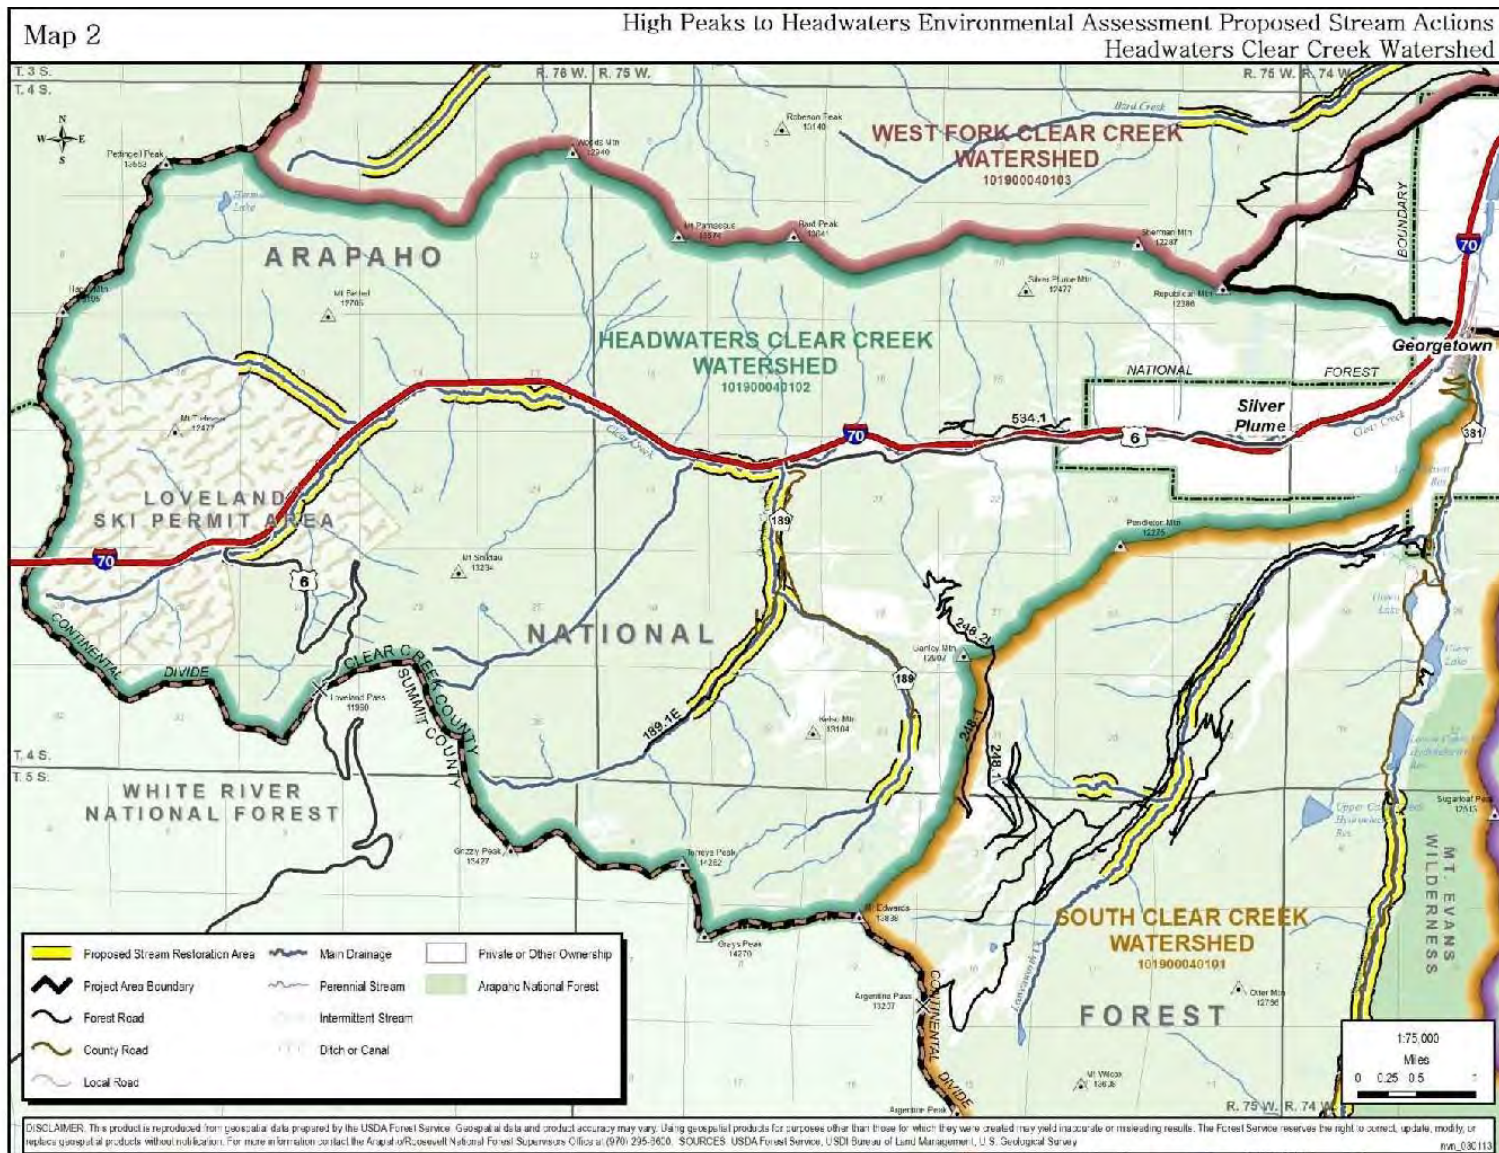
Figure 4-4: Headwaters Clear Creek Proposed Stream Improvement Projects
(Source: Map 2 High Peaks to Headwaters Fisheries and Watershed EA, USDA-FS, 2013)

- Place boulders and/or log structures on approximately 24 miles of streams
- Restore, and otherwise stabilize, approximately 20 miles of streambanks in the Headwaters Clear Creek (10190004-0102)
- Install and/or replace up to 15 road/stream crossing structures with those designed to pass aquatic organisms
- Perform general road maintenance on roads having impacts to wetlands or aquatic habitats
- Decommission 6.9 miles of Nation Forest System roads

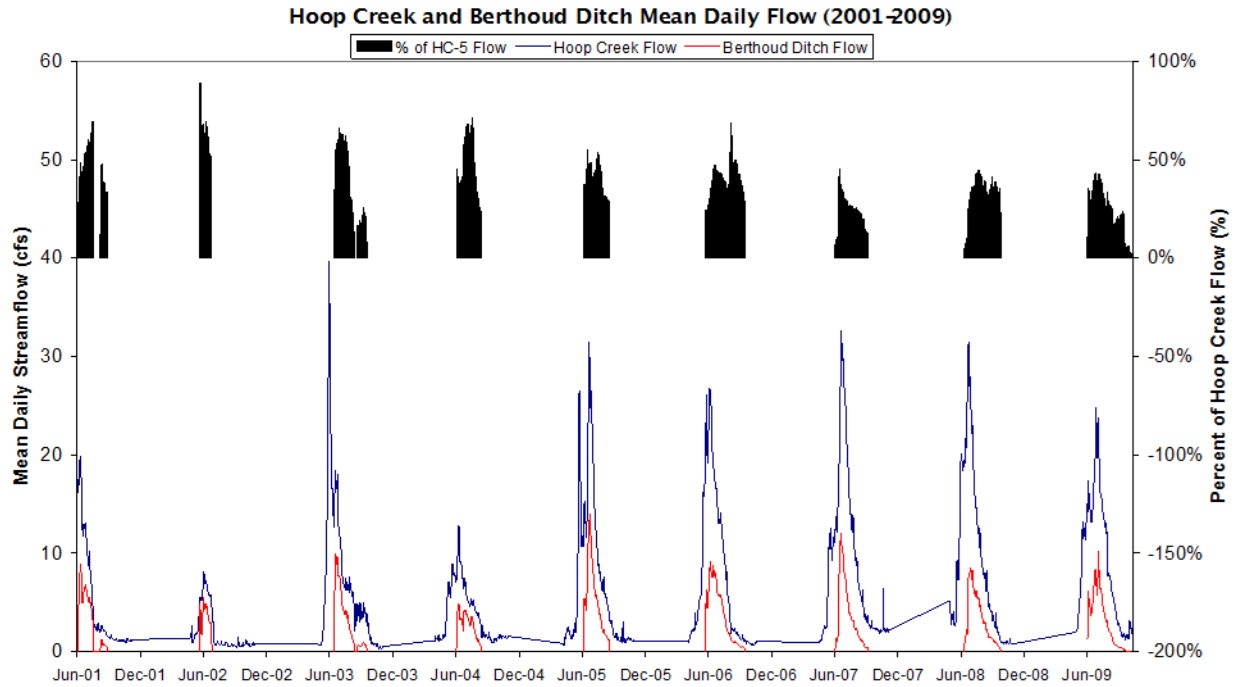
Figure 4-6: Hoop Creek and Berthoud Ditch

stabilization efforts did not extend far enough downstream and channel erosion has continued between the summit and Floral Park. This hydrologic modification is causing overbank flows, severe bank erosion, down-cutting of the channel, and excessive sediment transport in Hoop Creek and West Clear Creek.

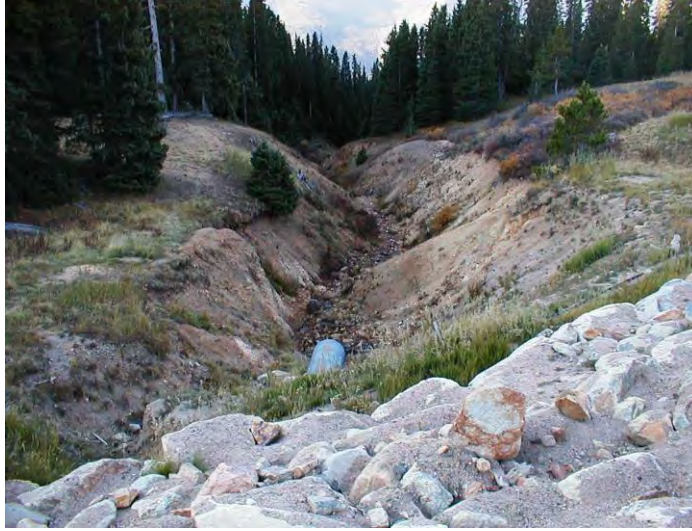
Figure 4-7: Berthoud Pass Ditch discharge channel showing massive soil loss September 25, 2001

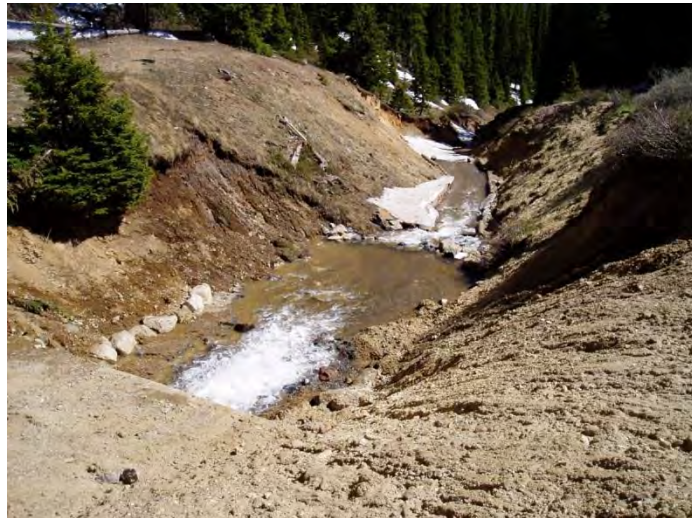
Figure 4-8: Berthoud Pass Diversion channel during construction June 17, 2005

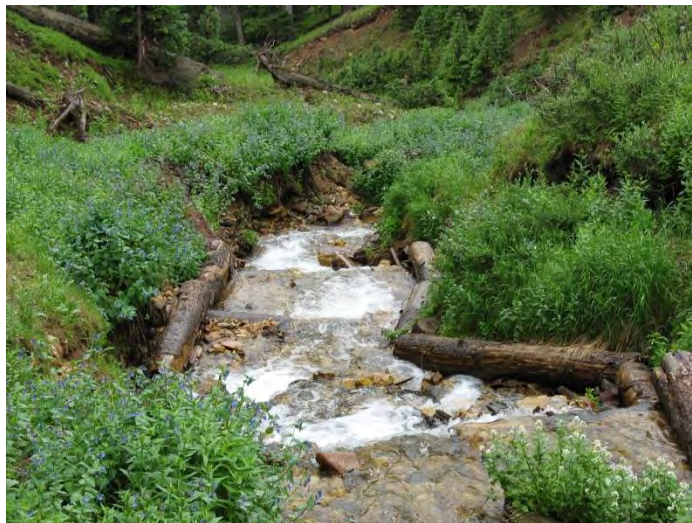
Figure 4-9: Berthoud Pass channel bank stabilization showing downstream erosion July 27, 2007

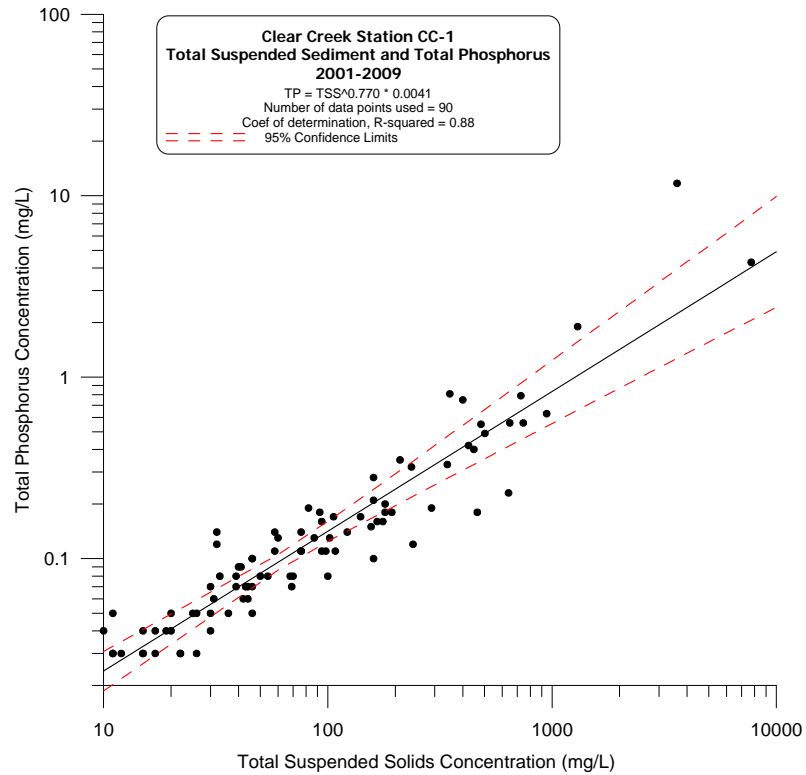
Figure 4-9: Total Suspended Sediment and Total Phosphorous

April-October period load and flow; base load assumes TSS conc. =5 mg/L

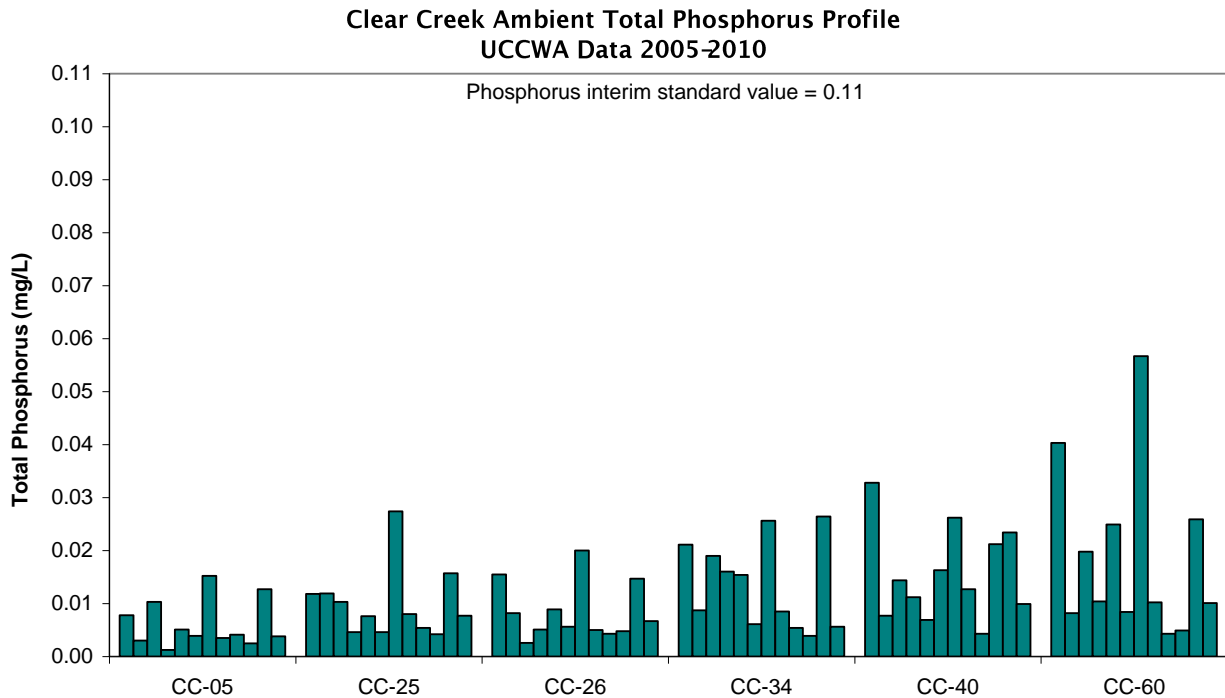
Figure 5-1: Sampling Data for Ambient Total Phosphorus 2005-2010

The results of this analysis indicate that total phosphorus concentrations in Clear Creek were below the interim standard value under ambient (non-storm event) conditions. The total nitrogen interim standard value is not achievable because background levels from nonpoint source areas in the Clear Creek Basin are higher than the interim standard value.

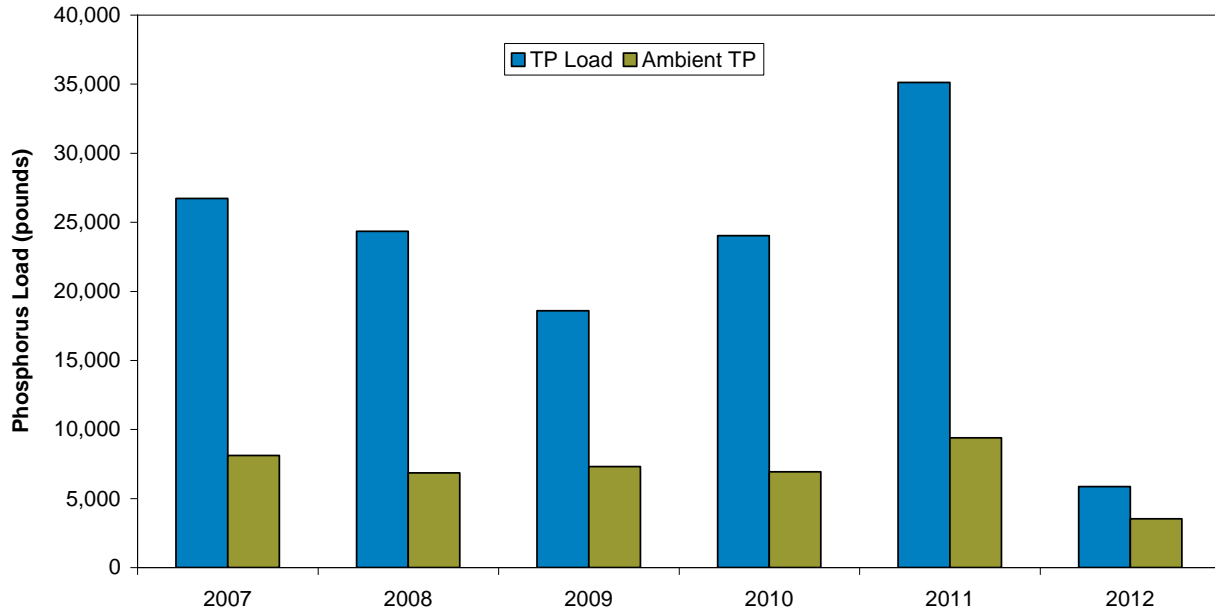
Figure 5-4: Phosphorus Load

**Clear Creek Station CC-59
April 15 to October 15 Total Phosphorus Load**

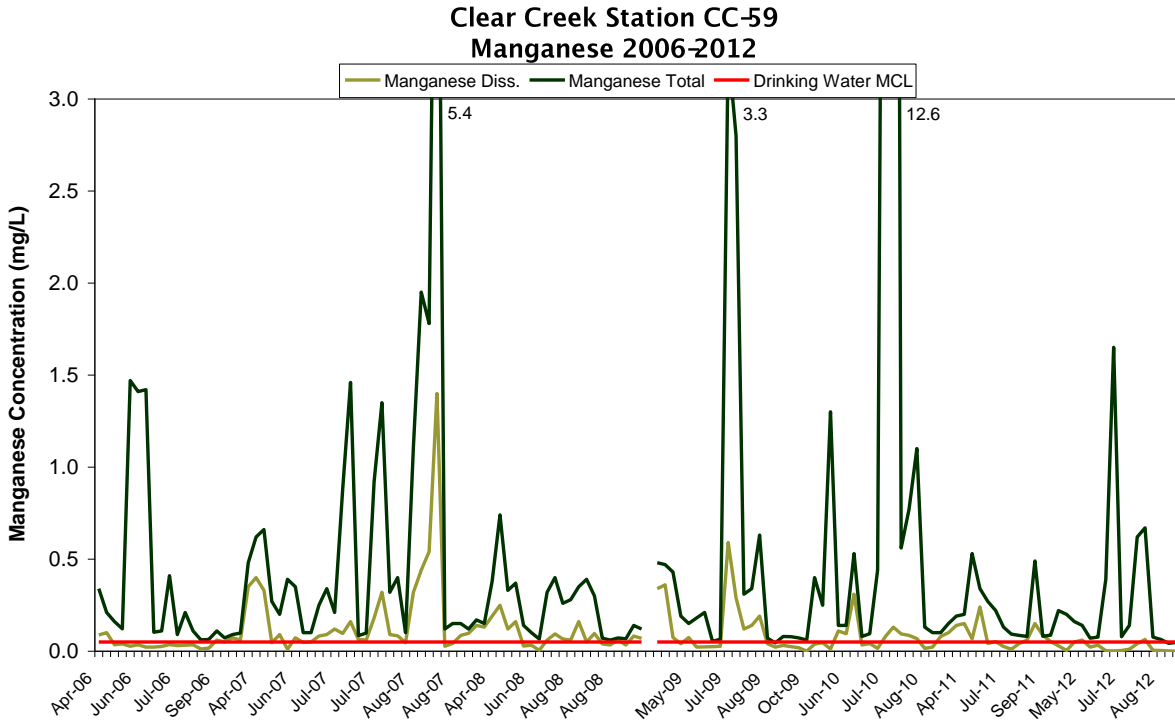
Figure 5-5: Manganese Concentrations

Metal concentrations including arsenic, cadmium, copper, lead, iron, manganese, and zinc can also be much higher than ambient levels during storm runoff conditions. The Clear Creek CC-59 data for manganese, an impurity in drinking water that can cause taste and odor problems, is shown in Figure 5-5. High manganese concentrations in Clear Creek have caused treatability issues for the City of Golden water supply. These data show that manganese regularly exceeds the drinking water maximum contaminant level (MCL) under storm event conditions.

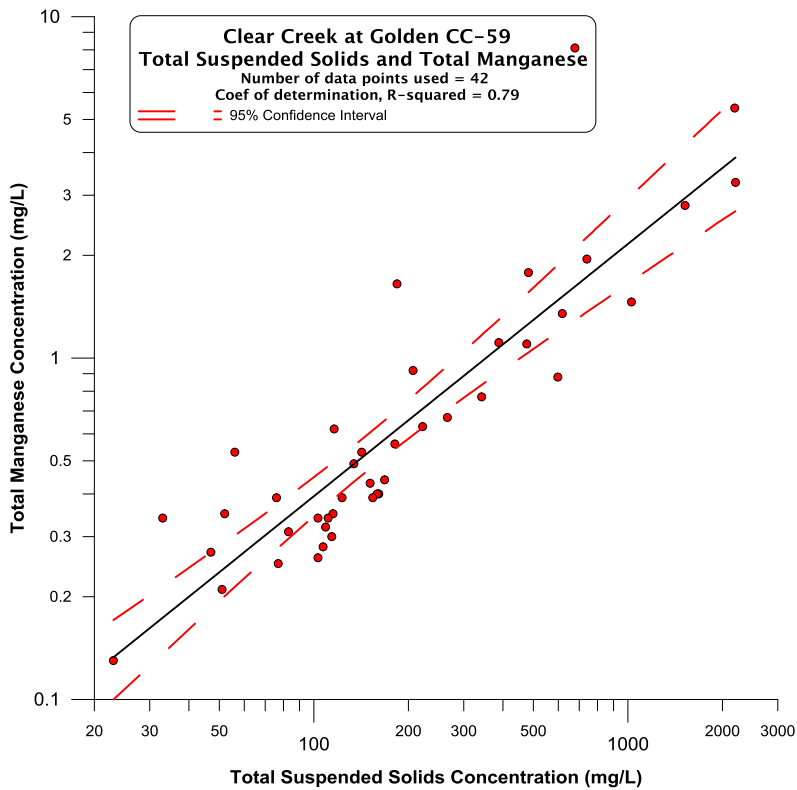
Figure 5-6: Suspended Solids and Total Manganese

The relationship between manganese and sediment is illustrated in Figure 5-6, which shows a strong positive correlation between total manganese and suspended solids. A similar relationship exists for cadmium, copper, lead, iron, and zinc.
